Cowichan Shoreline Stewardship Project: 2017 Annual Report

Cowichan Lake and River Stewardship Society
PO Box #907
Lake Cowichan BC V0R 2G0

Christine Brophy, CSSP Project Manager

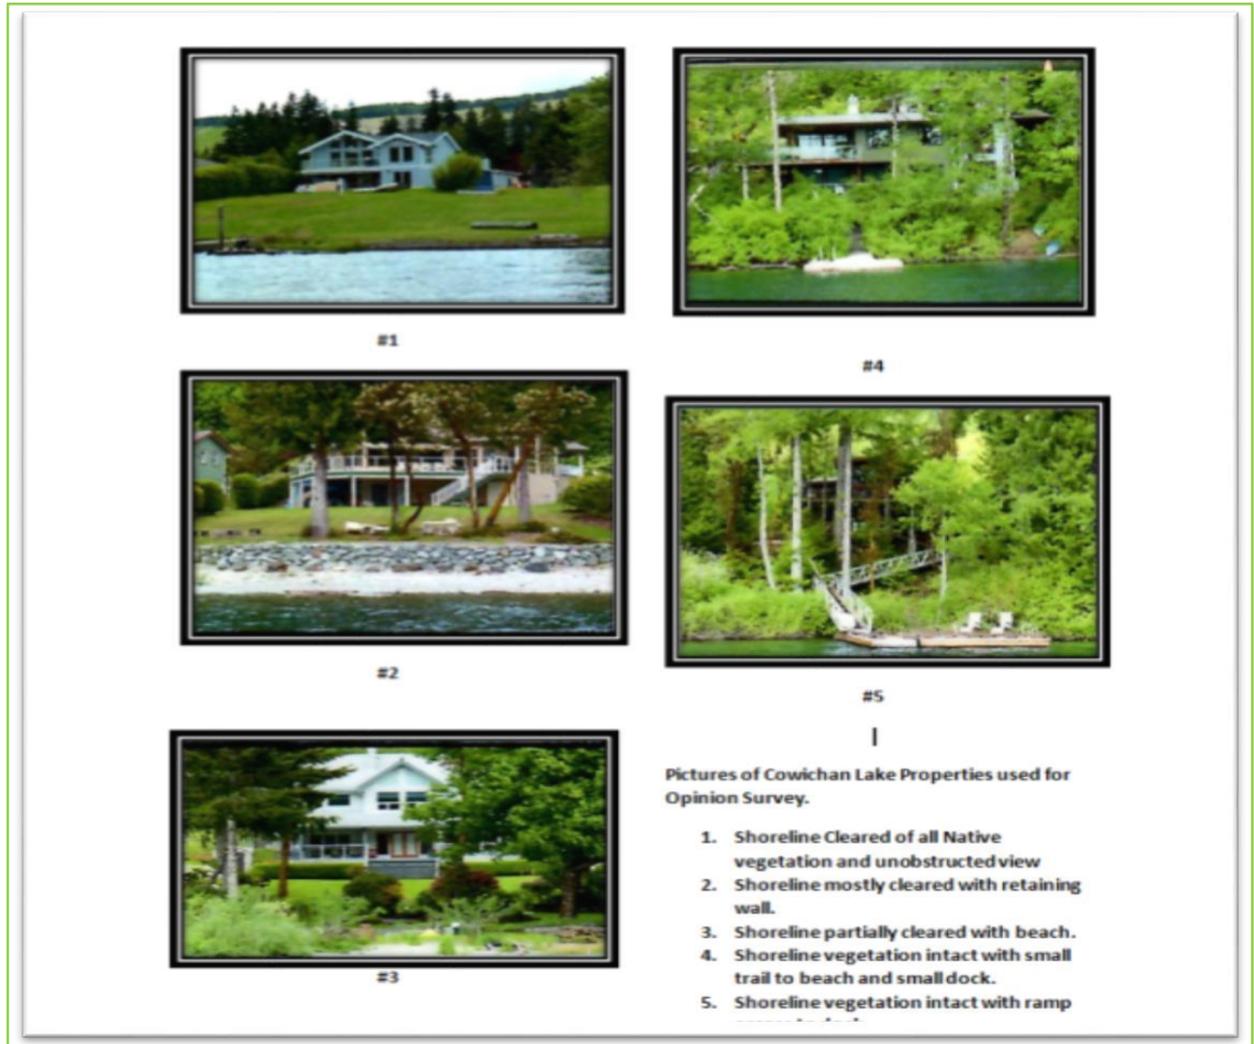
Figure 3. Five photos showing typical riparian conditions in the Cowichan Lake study area.

For the attitude and preference questions, a series of 5 photographs (Fig. 3), representing a variety of shoreline residences and “treatments” of vegetation along the shoreline were shown to landowners. The photos used in the 2017 survey represent five typical riparian situations that exist in the Cowichan study area.

In terms of environmental conditions, there was a modest decline (of 7.5%) in landowners' preference for the least disturbed shoreline in 2017 (i.e., photo #5). From 2014 to 2016, survey results remained relatively consistent. That said, the four year trend suggests there is still a need to increase public education about healthy shorelines, a task CLRSS continues to lead with enthusiasm (Table 3).

In terms of strict economic considerations, there was an apparent shift in landowner preference with photo #5 polling a surprising 51% of respondent support in 2017 (Table 4). This result is more in line with 2017 results in Table 2, where more shoreline residents are beginning to recognize the inherent (and not necessarily monetized) values of preserving natural riparian areas.

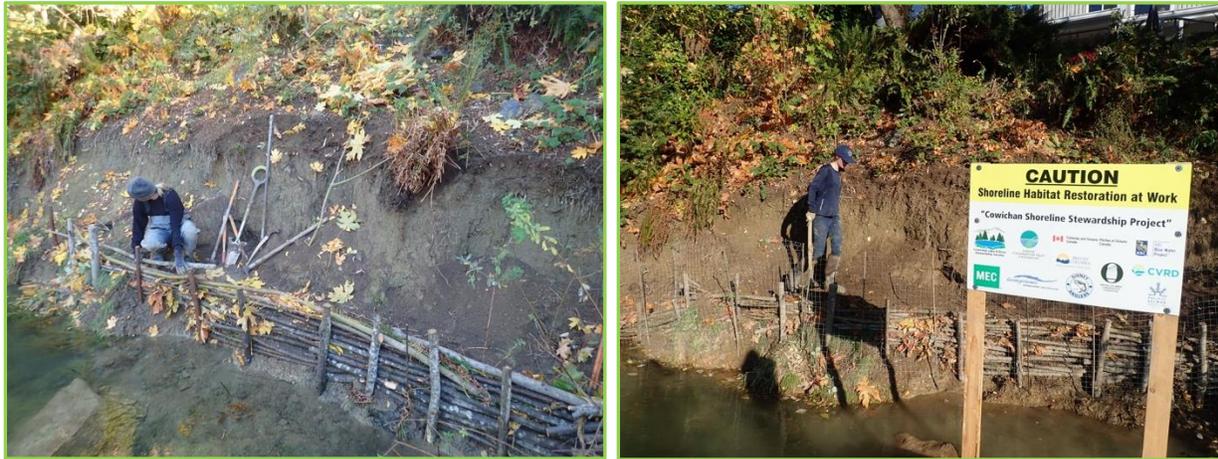
Figure 6. Construction of a live-stake wattle fence at a CSSP 2017 site along Cowichan River.

Another method of bioengineering using live-stake cuttings termed “live wattle-fence construction” was implemented in 2017. Live-wattle fences were used as a natural construction method for river bank

protection and erosion control (Fig. 6). Wattle-fences were used at two of the private properties and live-staking was completed at one public property. In 2017, 25% of the sites required live-staking or wattle-fencing due to the shoreline having steep slopes, extensive erosion, or were located on a riverbed where potted plants cannot be used effectively.

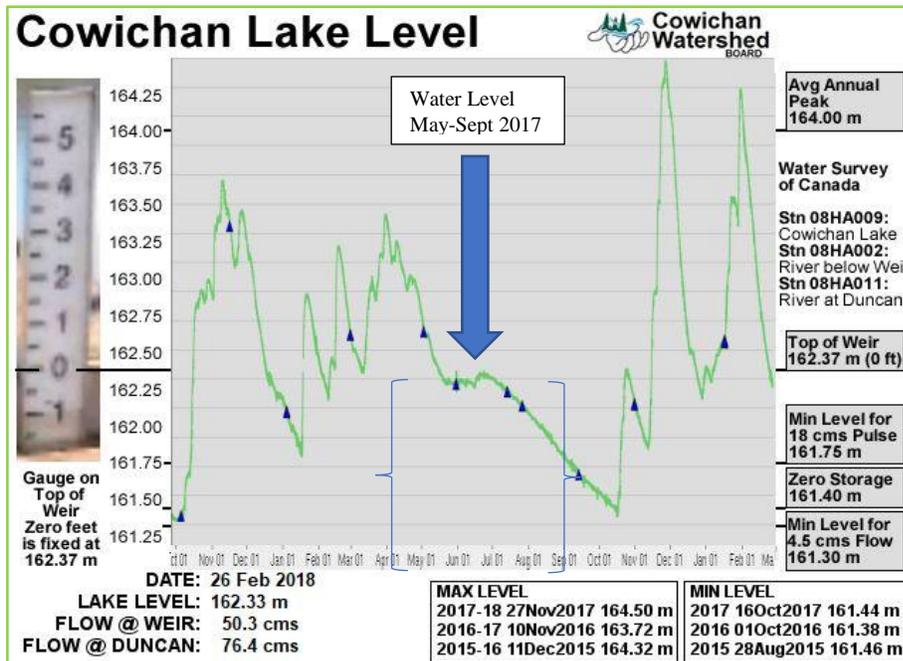
Figure 7. Cowichan Lake water levels during CSSP planting May to September 2017 (Cowichan Watershed Board, 2017).

September 2017, Cowichan Lake levels declined steadily (Fig. 7), and average air temperature was approximately 20°C for July and August (Fig. 8; Gov. Canada 2017). Daily summer maximum temperatures were considerably warmer.

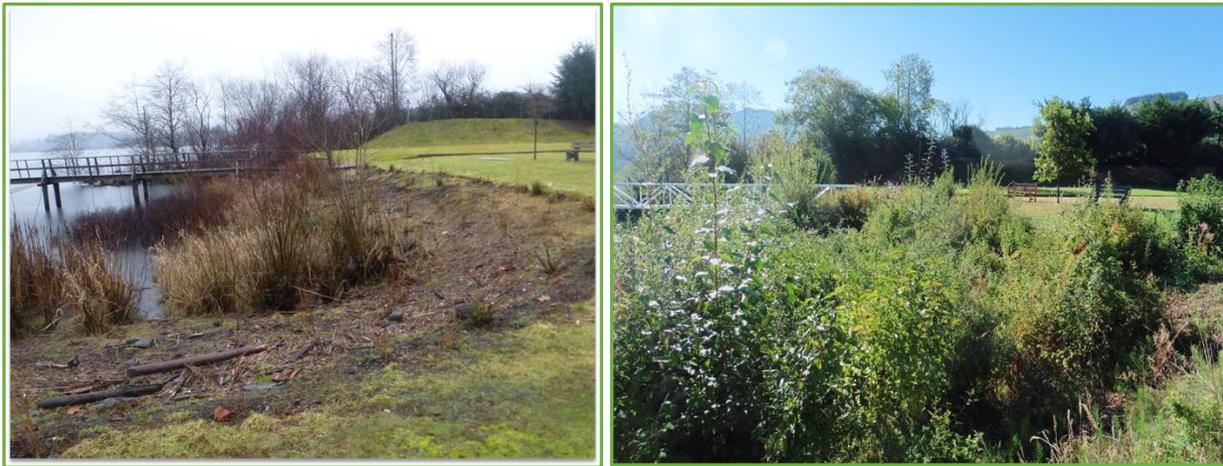
Figure 9. Before (2014) and after (2017) at Paradise RV Park, a 2014 CSSP riparian restoration site.

Fig. 9 shows an example of photo-point monitoring from a 2014 CSSP site that displays the progression from a cleared foreshore to its current status in 2017, exhibiting substantial growth of re-introduced riparian species which are contributing to shore stabilization and habitat creation.

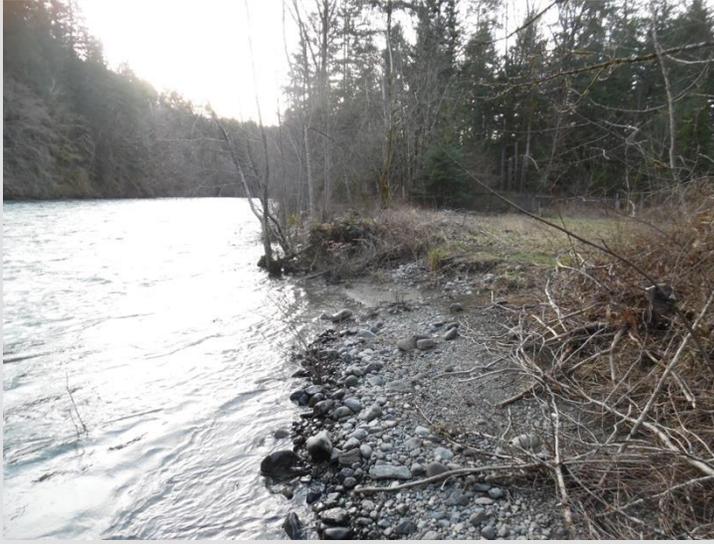
- Facing upstream
- Willow live-staking throughout eroded area

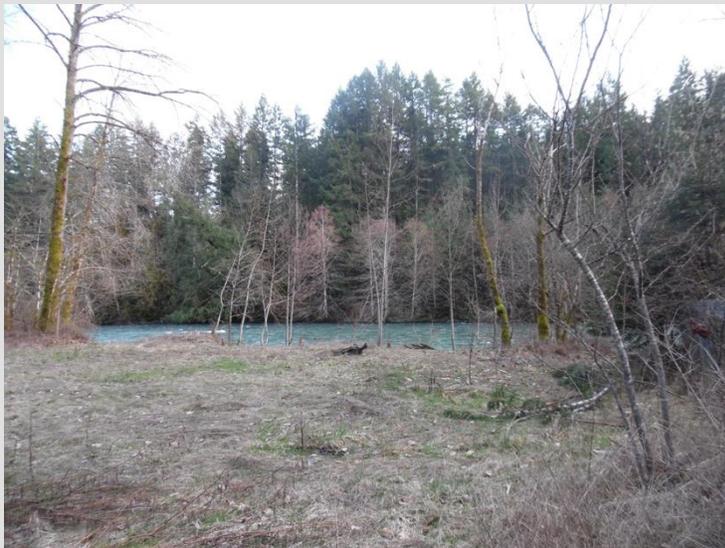
- Field upland planting polygon to be planted with diverse amount of upland riparian species suited for drier soils
