FINAL REPORT

Cowichan Bay Float Homes and Live-aboards

Prepared for:
Cowichan Valley Regional District
Community and Regional Planning Division

File: 1123-002.01
February 2013

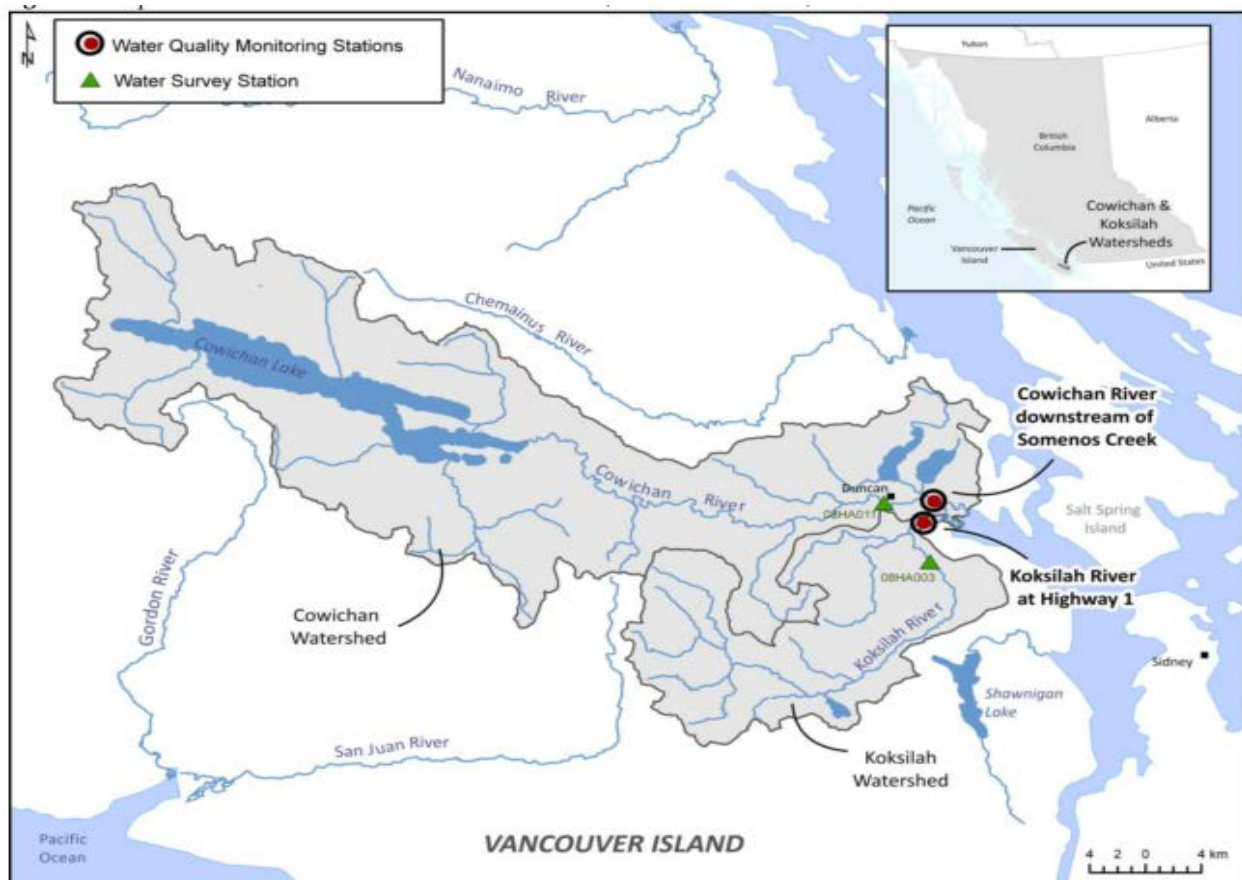
Figure 4 Water Quality Stations on the Cowichan and Koksilah Rivers

The Cowichan and Koksilah rivers are influenced by non-point source (logging, agriculture, urban development) and point source (Duncan-North Cowichan Joint Utilities Sewage Treatment Lagoons, the Town of Lake Cowichan sewage treatment plant, and Catalyst Paper) inputs (Dessouki 2010, Obee 2011). Water quality monitoring stations are located one kilometre upstream of the Cowichan estuary in both rivers (**Figure 3**; Obee 2011).

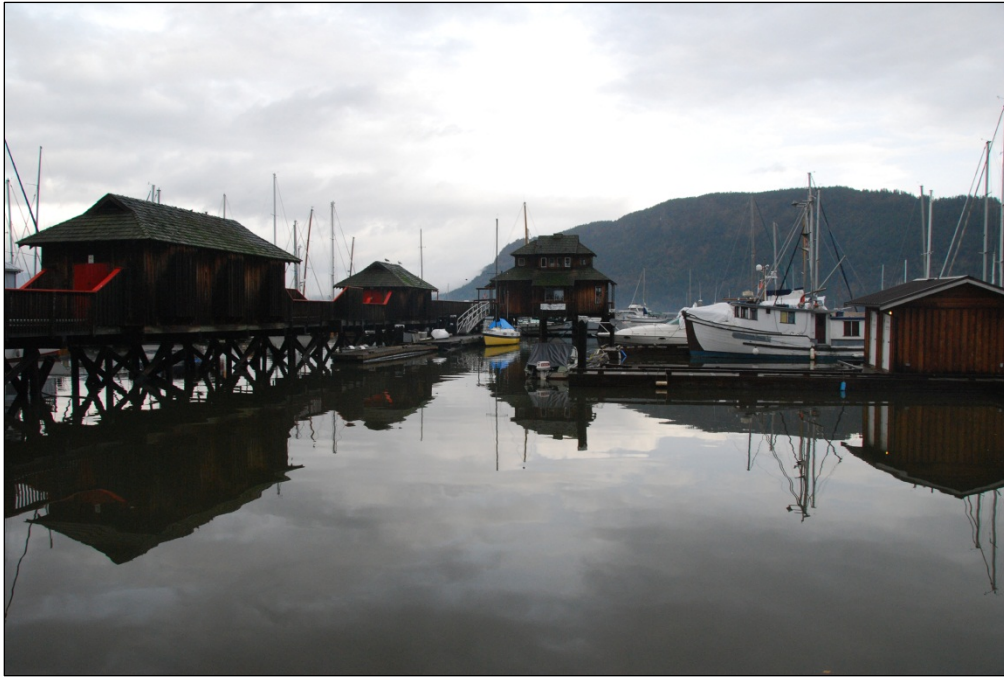
Photo 3: Pile supported structure: Wooden Boat Society

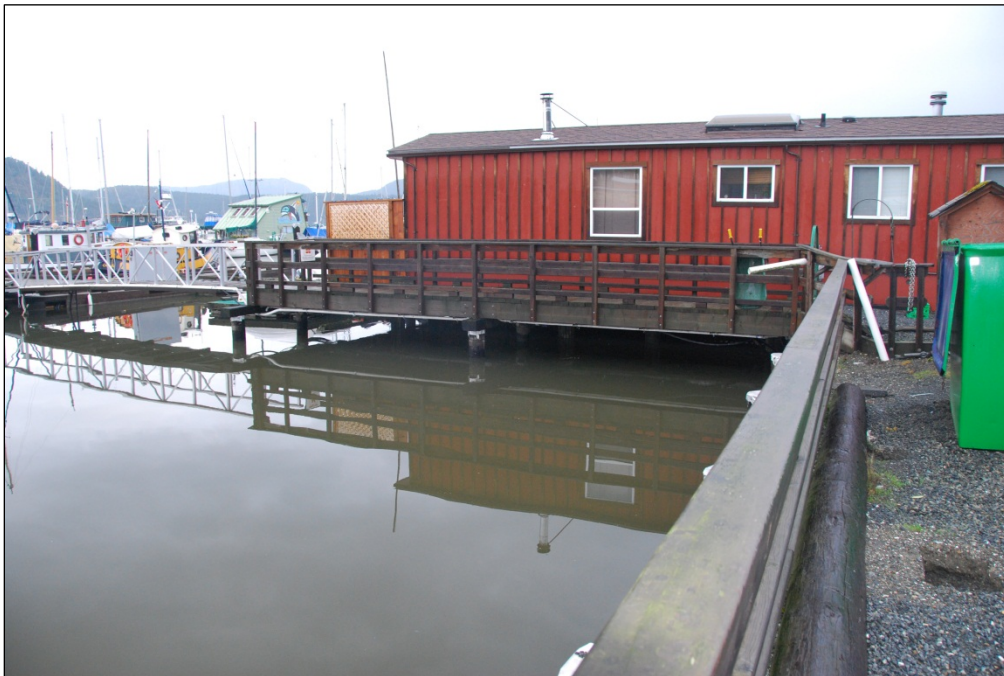
Photo 4: Overwater structure

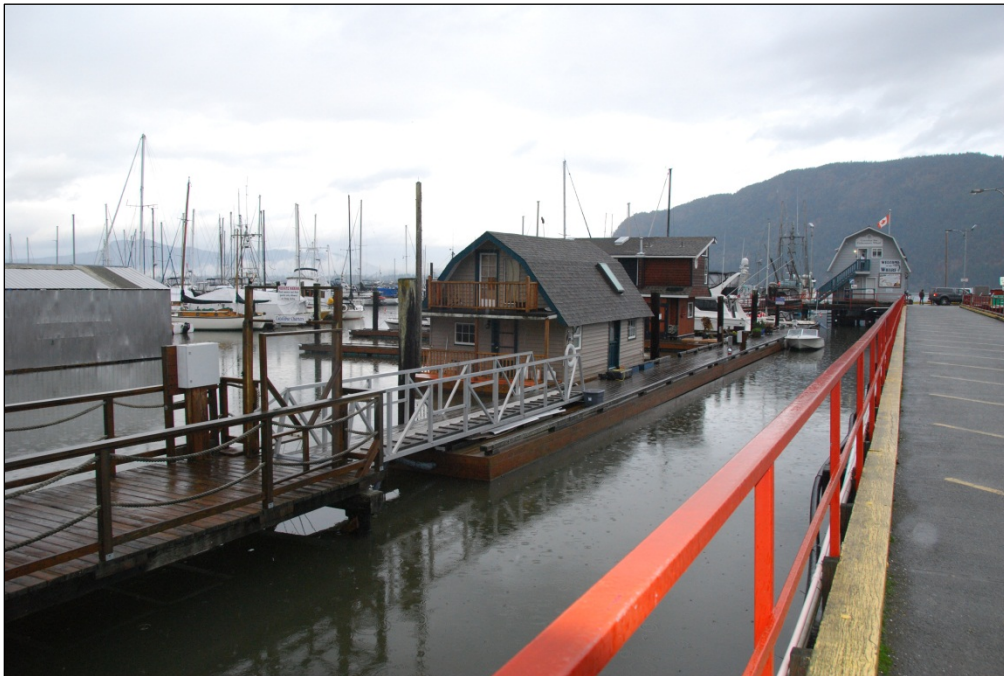
Photo 10: Floating residence near government wharf

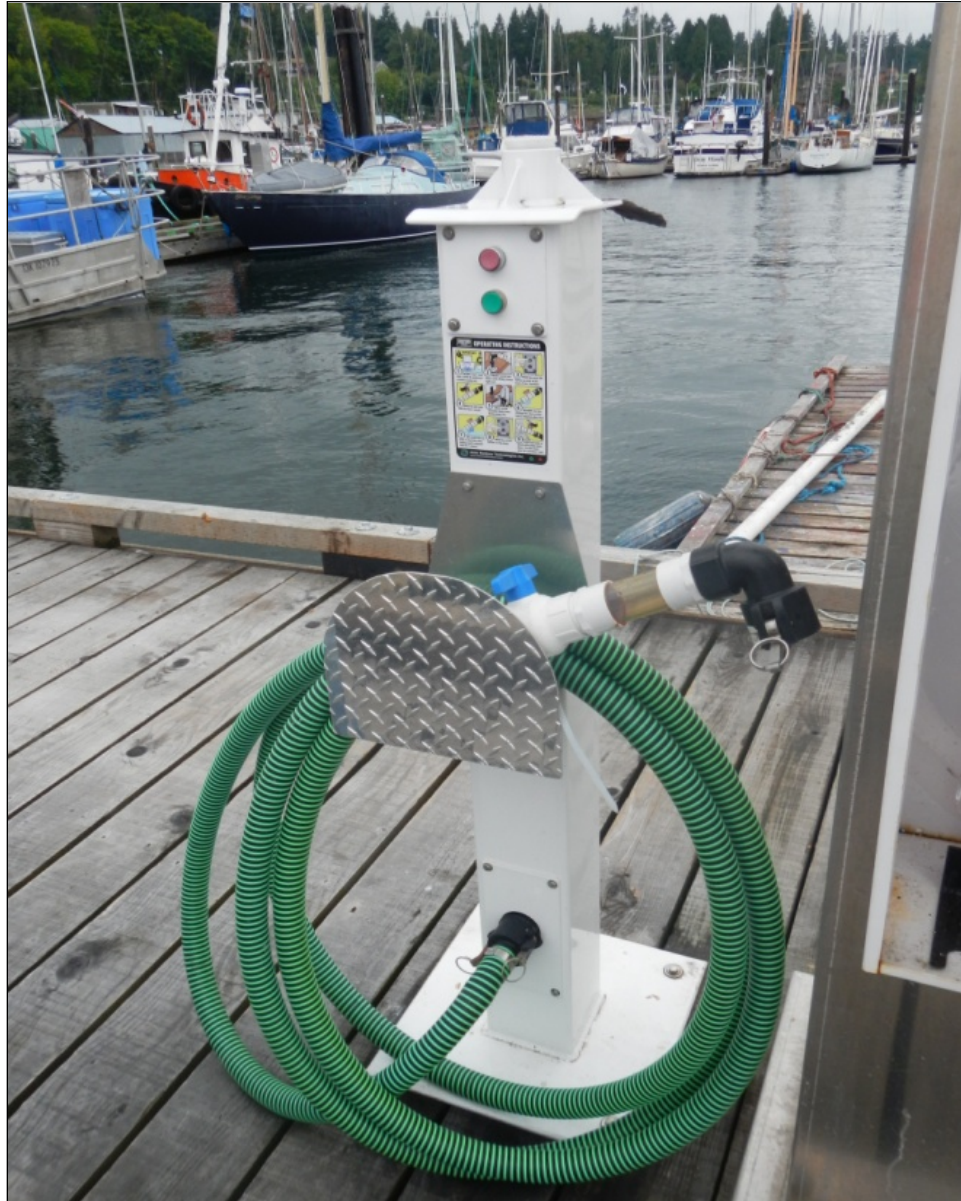
- The Fisherman's Wharf Sewage Management System (SMS) consists of a recently upgraded infrastructure. Starting at the end of the North finger of the dock with a Boat Sanitation Dump.

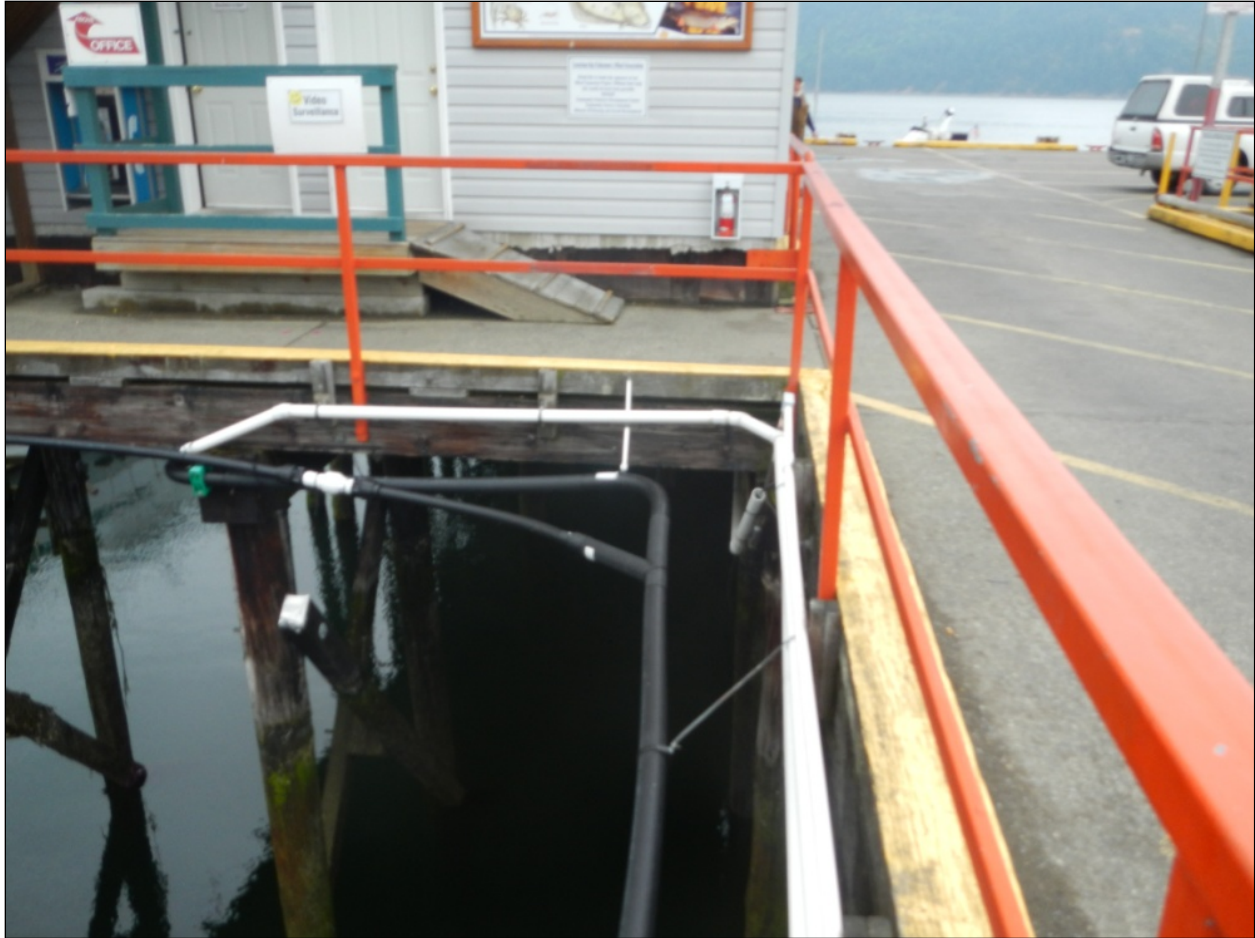
- This pump discharges the sewage through a short length of white 50mm PVC (polyvinyl Chloride) Spa Flex pipe located directly after the pump (Note Spa Flex pipe only has a working pressure rating of 65psi, and isn't commonly used on pump discharge piping) where it transitions into a 50mm HDPE pipe secured to the bottom of the ramp to the wharf at which point the 50mm HDPE wyes into a 75mm HDPE force main after passing through a 50mm PVC check valve to prevent back siphoning.

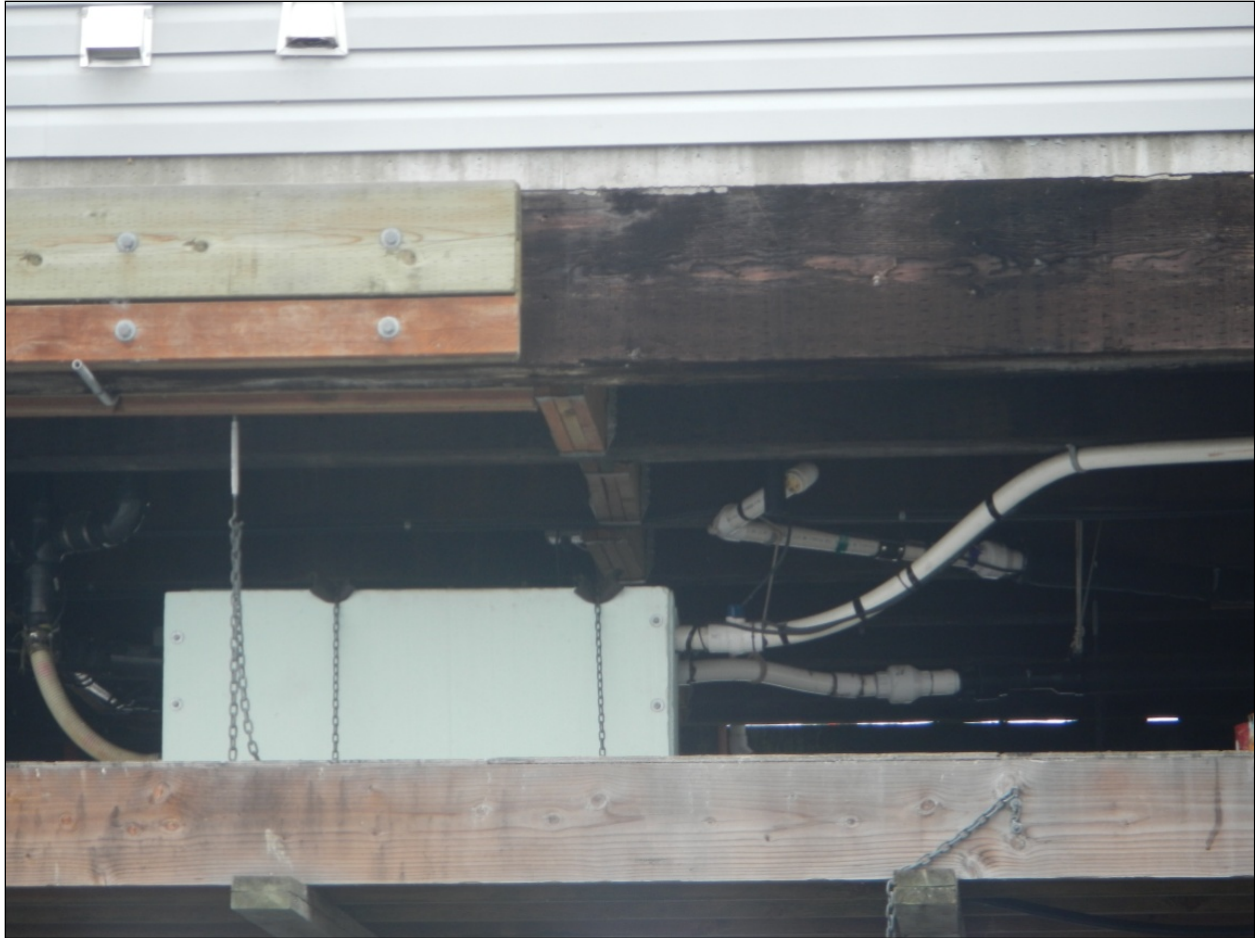
- The 75mm HDPE force main is the discharge piping from the Holding/Pump Chamber located under the Fisherman's Wharf building.

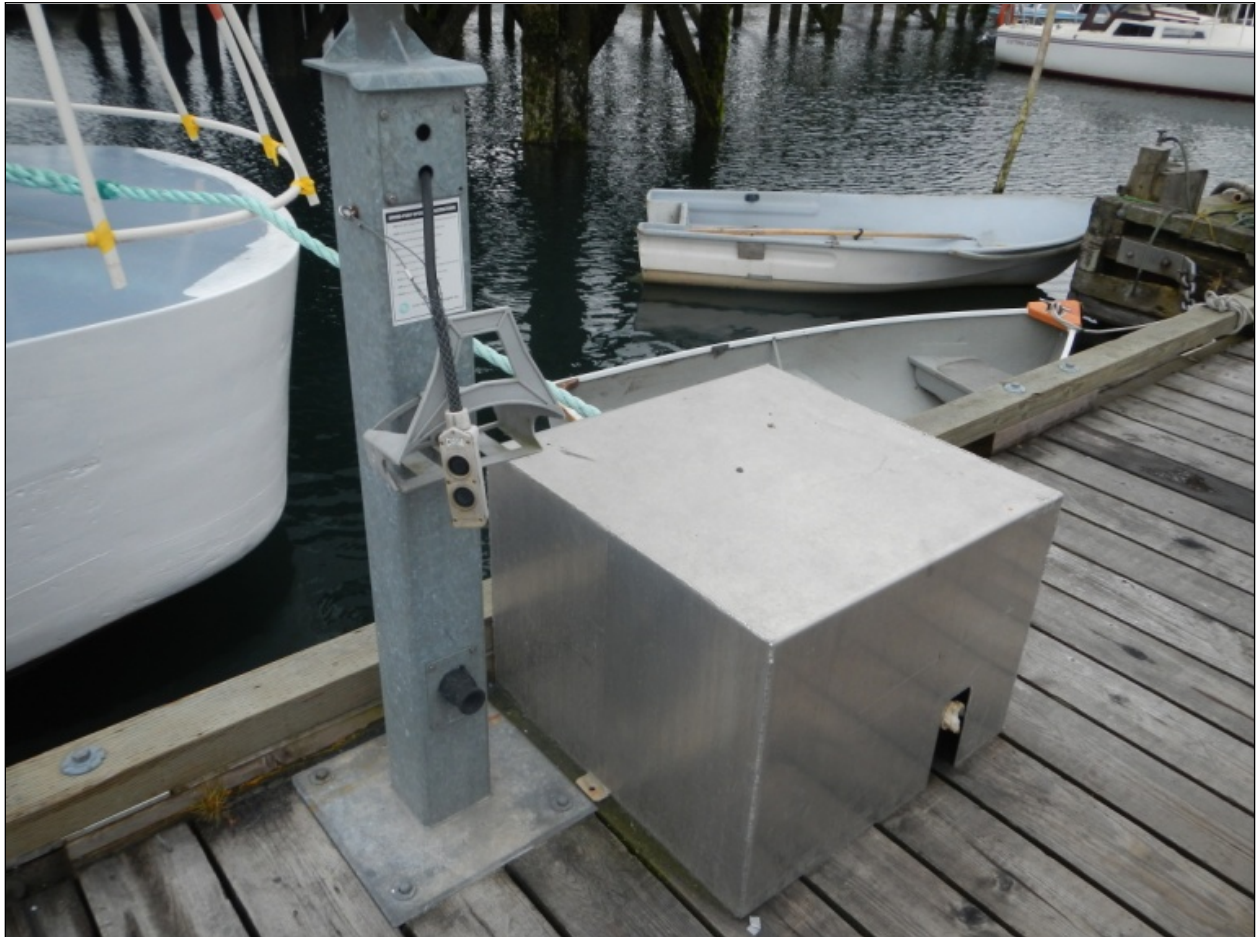
- The Holding tank seems to be constructed of Polyethylene, the 75mm sewage discharge pipe, transitioned from a short section of Spa Flex through a check valve to the HDPE Force main.
- The tank has two 50mm inlets, one on the lower left side of the tank taking the grey water and sewage from Fisherman's Wharf building, and one on the upper right side of the tank with PVC ball valve in the closed position. This inlet pipe to the tank is the discharge pipe from an abandoned Boat Sanitation Dump which is no longer physically connected to the unit.

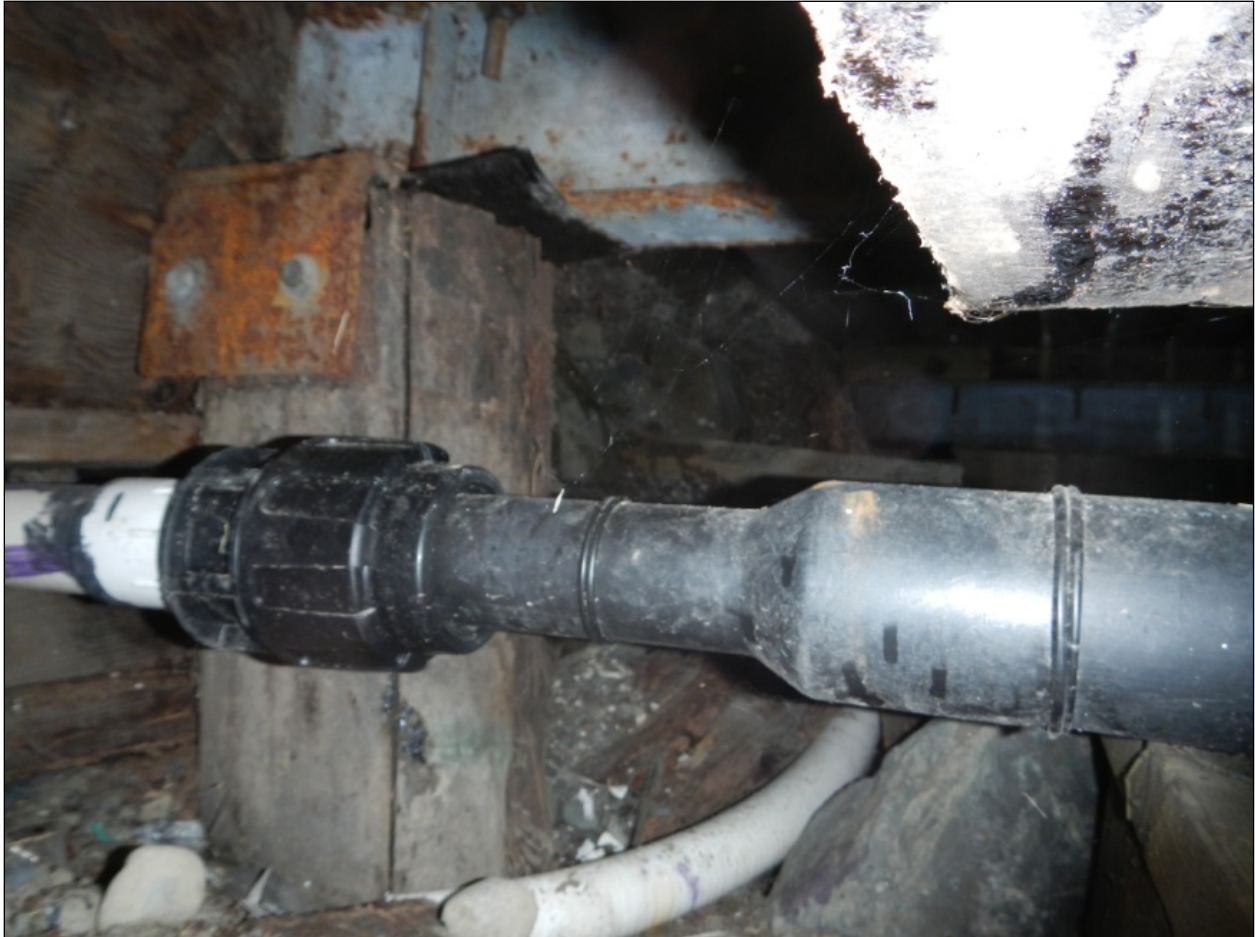
- The 75mm HDPE Force Main from the Holding tank below the Fisherman Wharfs building is secured to the side of the wharf where it continues to the shore line, then drops below the wharf where it transitions from 75mm HDPE to 50mm then to 50mm schedule 40 PVC pipe at which point it enters into the ground.

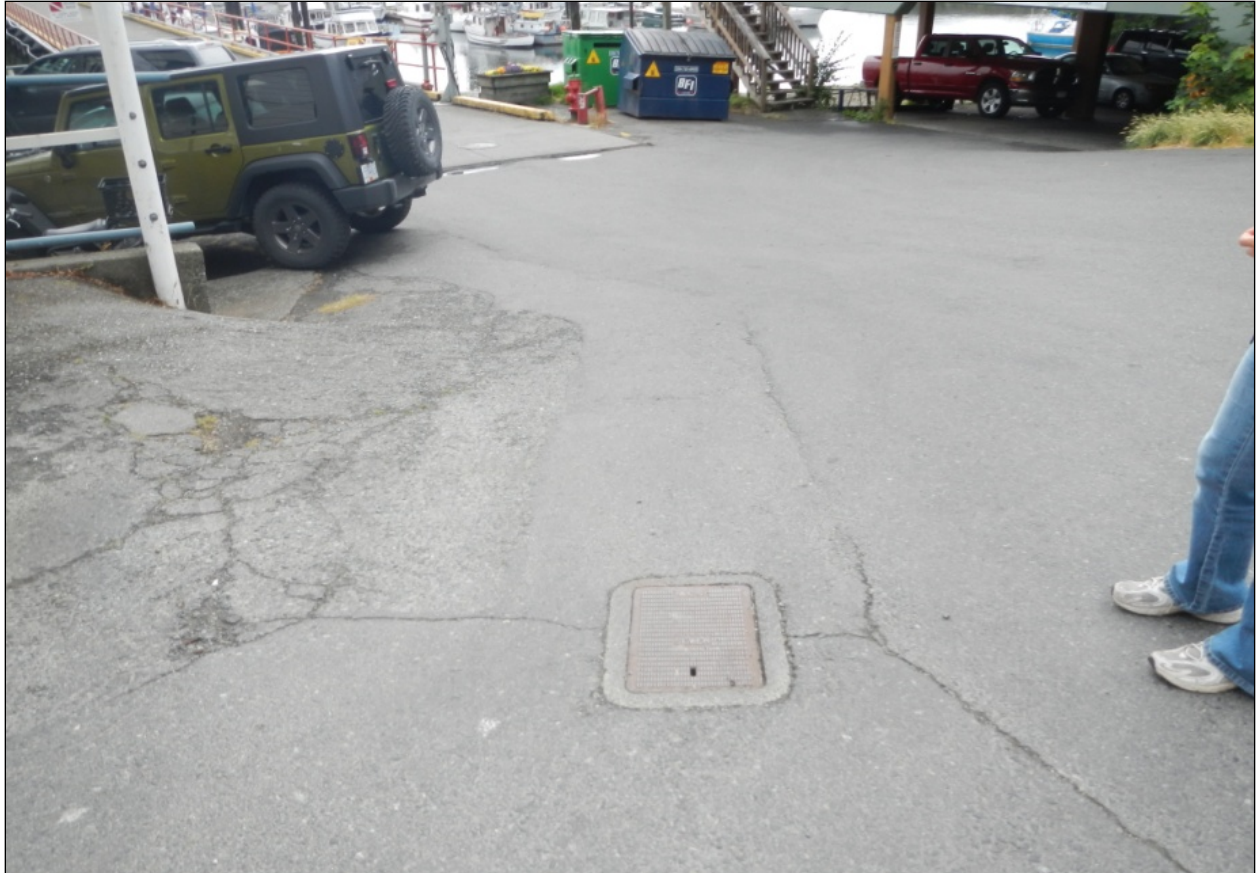
- This service then continues to a sewer clean out located in the driveway for the wharf, at which point the flow gravities into the CVRD Sewer Infrastructure.

- Note clean out box needs to be cleared of debris to access clean out and confirm connection.
- Service connection to CVRD Sewer Main located 12.2m downstream of manhole 18.

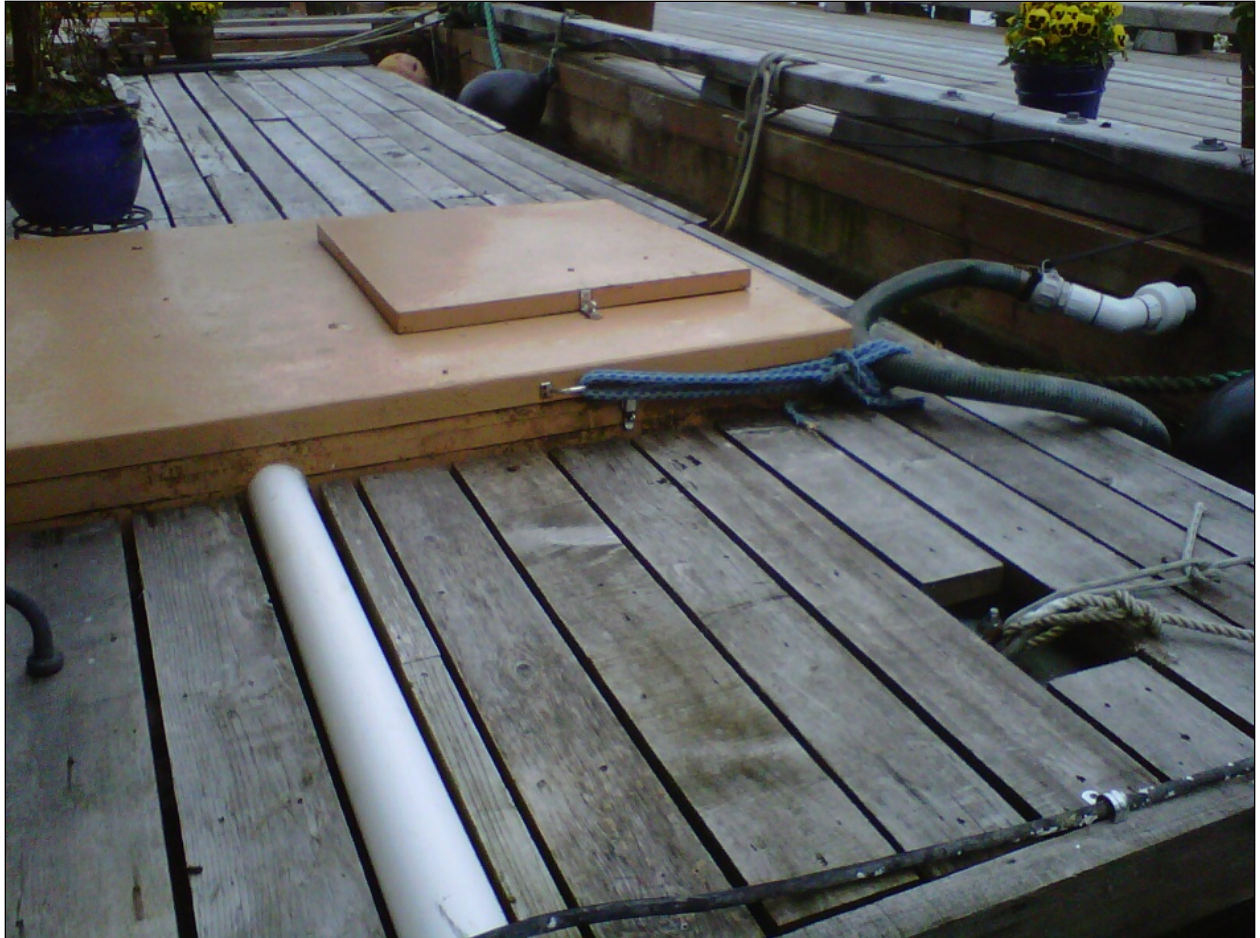
- The Mast head Marina's SMS is compiled of a variety of materials servicing two out of three float homes.
- Float home #3 is connected to the SMS via a Holding/Pump chamber located on the deck of the float home. The chamber is approximately 1.5m in length and 1m in width, unable to account for the depth we would have to approximate the volume at between 800 and 1000 litres. The chamber is attached to the force main through 50mm multipurpose PVC flex hose, then transitions to schedule 40 PVC pipe using a cam lock fitting, and using a PVC check valve before attaching to the SMS force main.

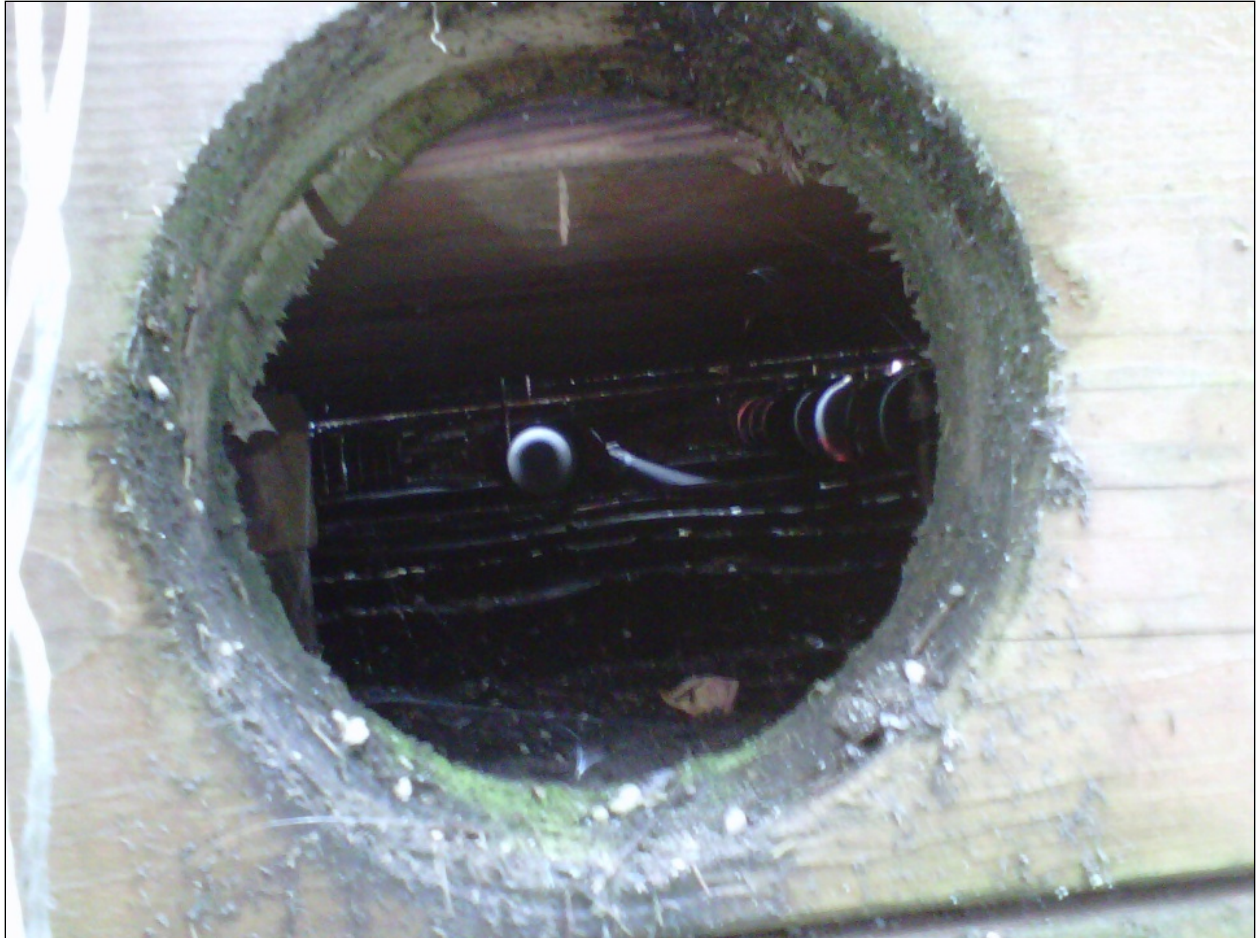
- Float home #2 has no visible connection to the SMS, although there seems to be a provision for a possible future connection. We would have to assume that this home is discharging into the bay.

- Above picture is access hole to force main in the dock adjacent to float home #2
- Float home #1 is connected to the system through a section of PVC Spa Flex using cam lock fitting's transitioning into schedule 40 PVC without any sign of a check valve, leading us to assuming that there must be a Holding/Pump chamber and Check Valve assembly aboard the unit.

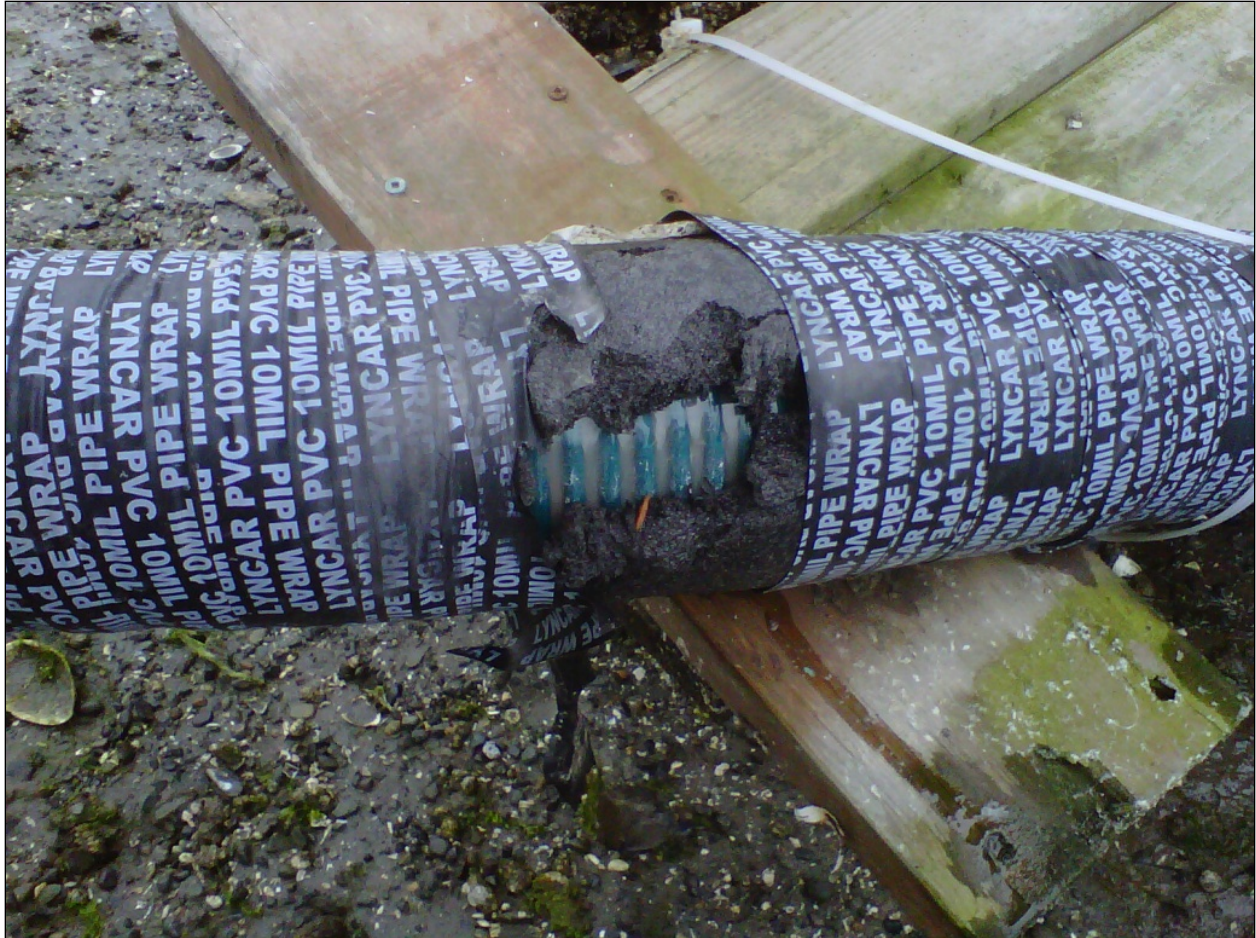
- It is an assumption because it is not visible and judging by the connections that the force main below the decking of the dock is 50mm schedule 40 PVC pipe, and that it transitions just before exiting the dock to 75mm clear Flex PVC with Green PVC helix, which has been wrapped in UV resistant tape.

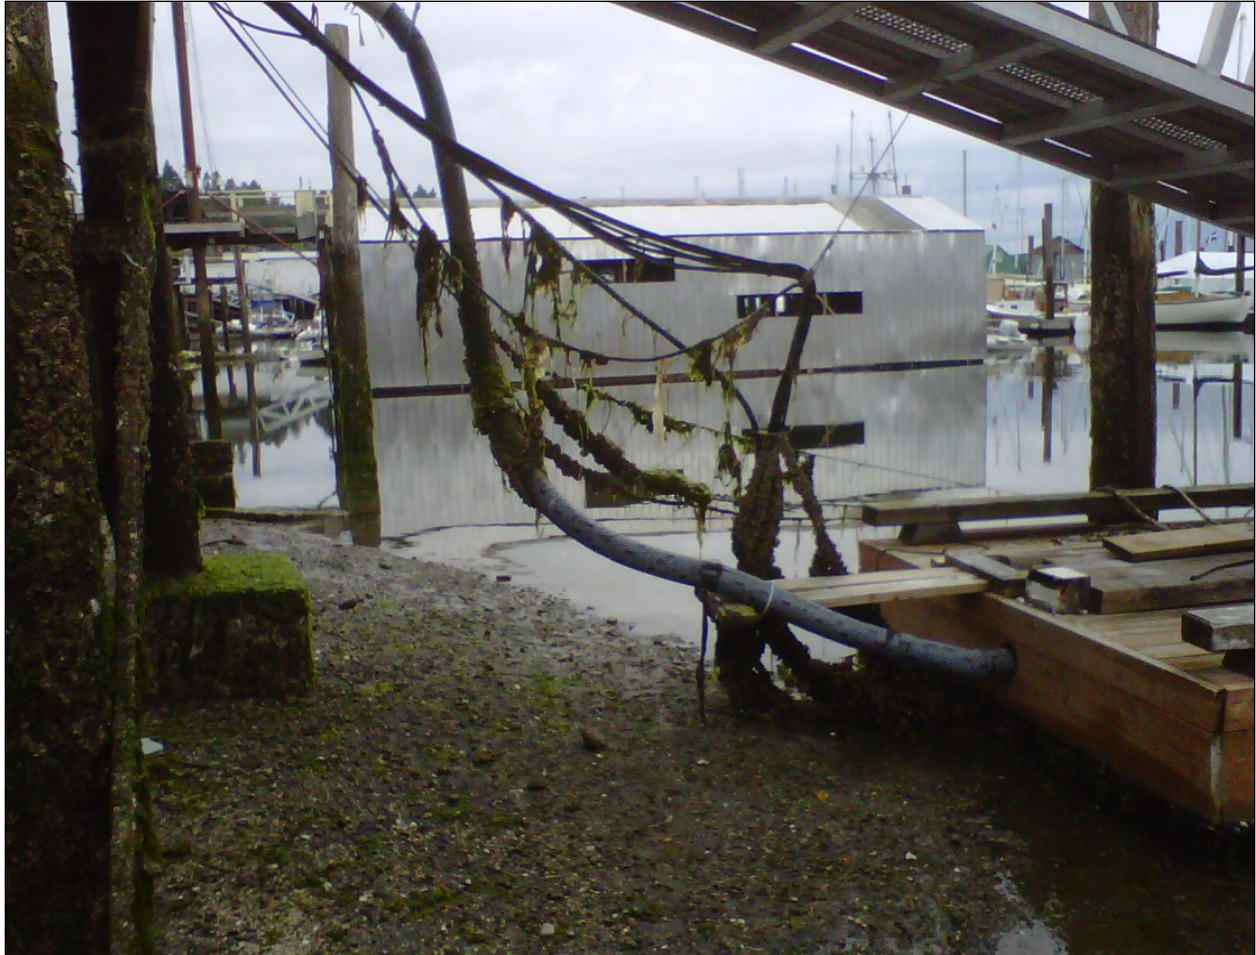
- The force main is somewhat secured to the ramp as it transcends from the dock to the wharf.

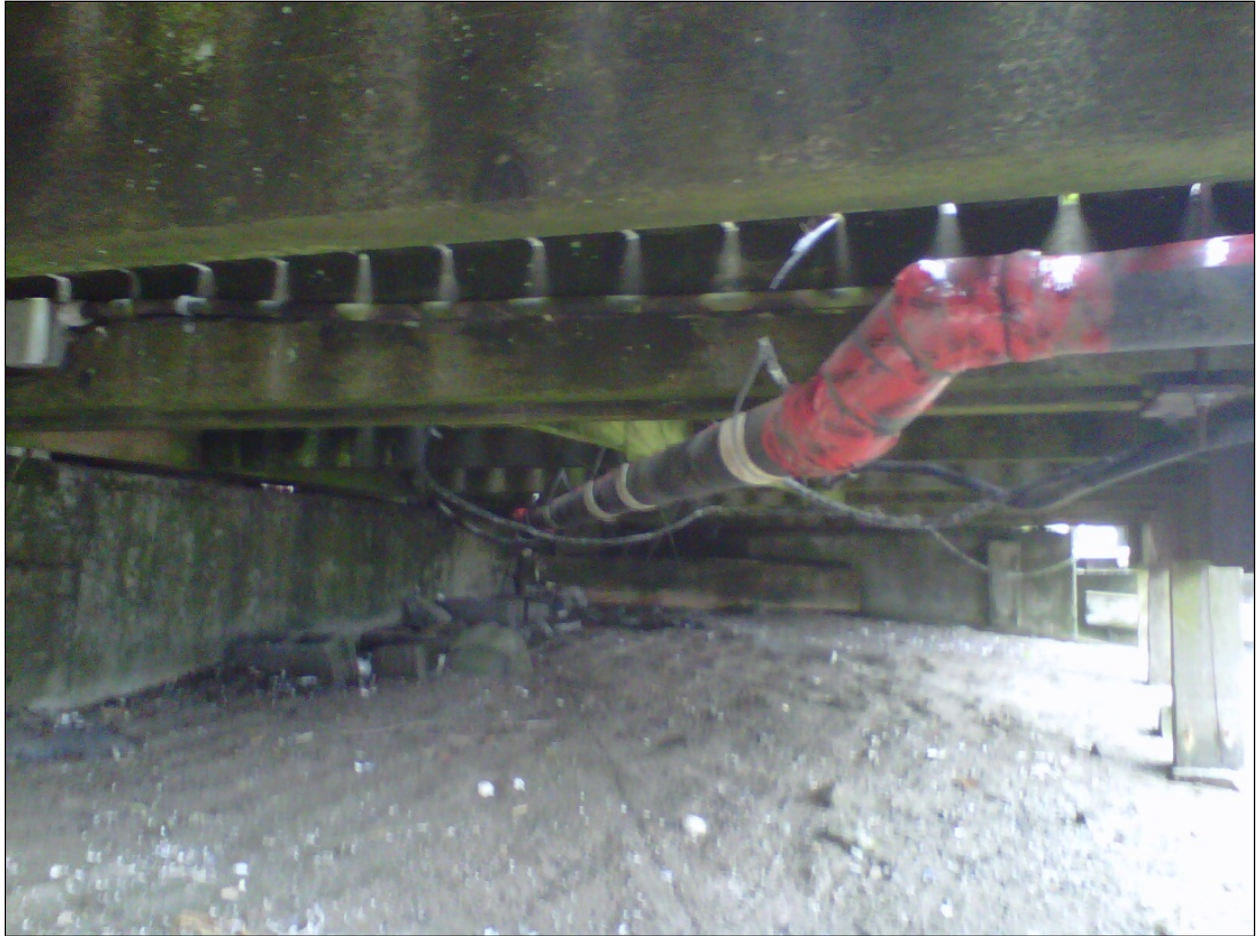
- The force main continues along the wharf then transitions into a gravity line located under the wharf just before the Masthead Restaurant at which point it gravities into the shared sewer service line for the restaurant.

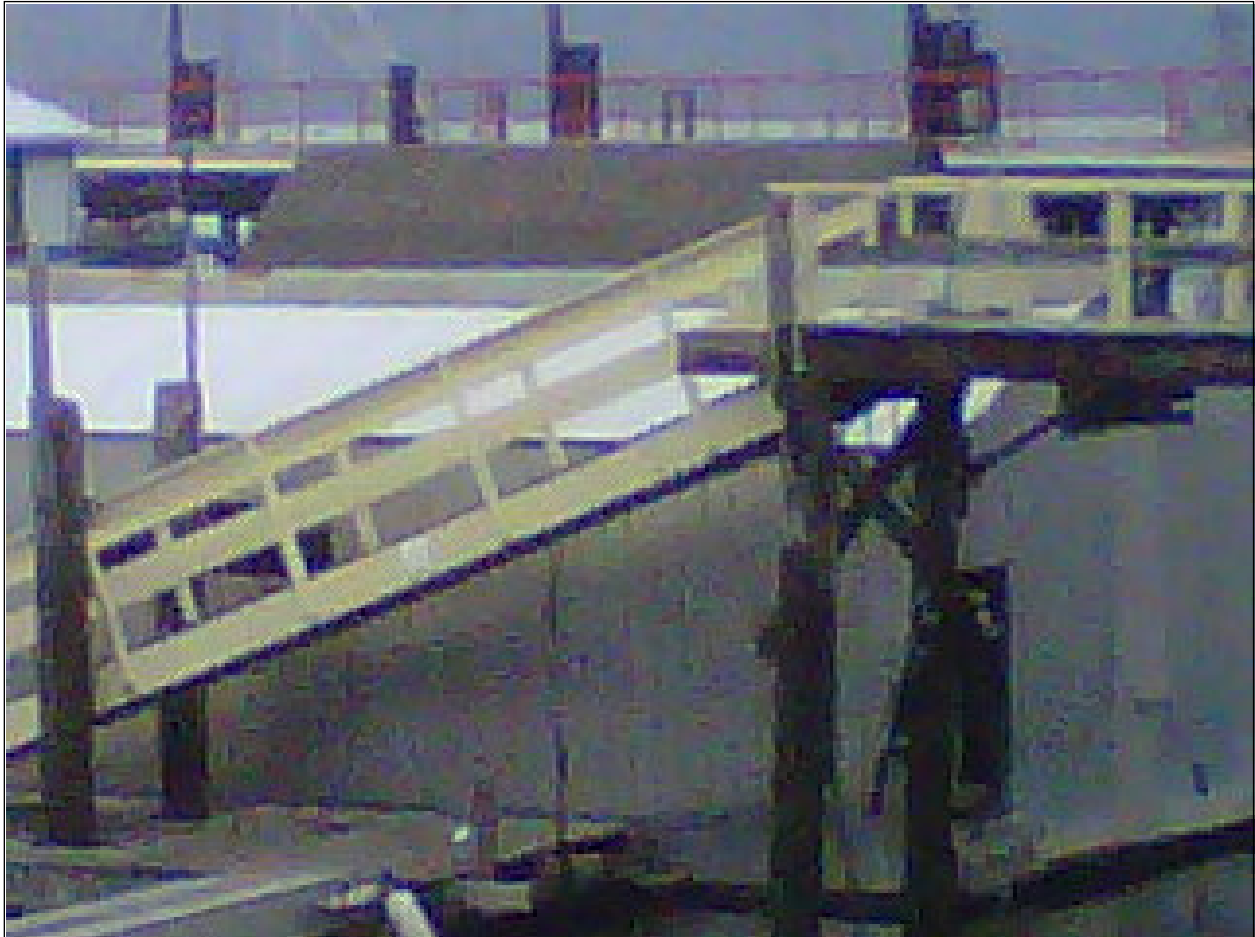
- Has no visible connection to its wharf system.

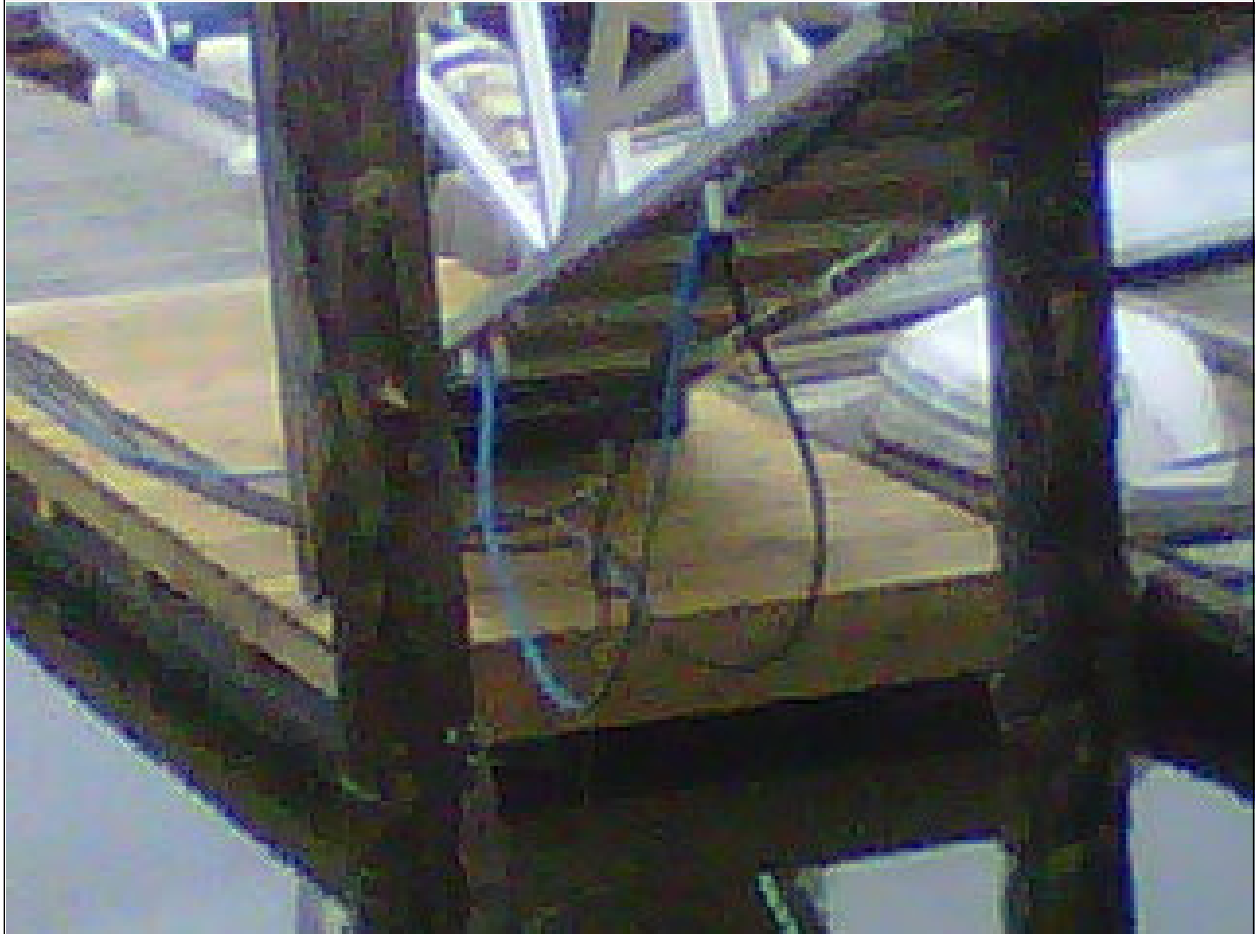
- Has no visible sewage connection to either of its wharf systems, although service for power and potable water are present.

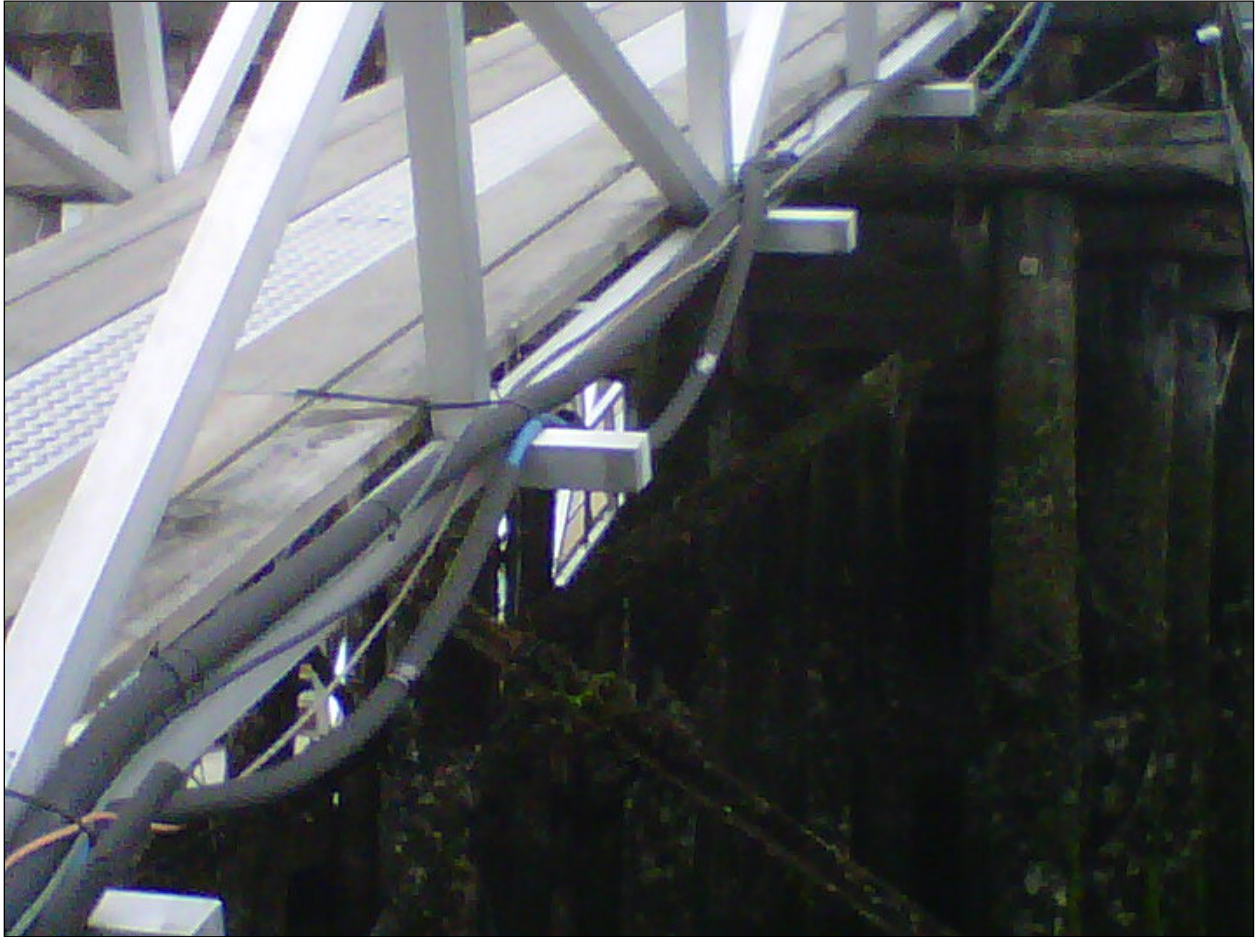
- Pier 67 currently maintains moorage for four float homes. Recent upgrades have been made to the wharf system, although without provision for a sewage management system for the homes. Again service for water and power are visible.

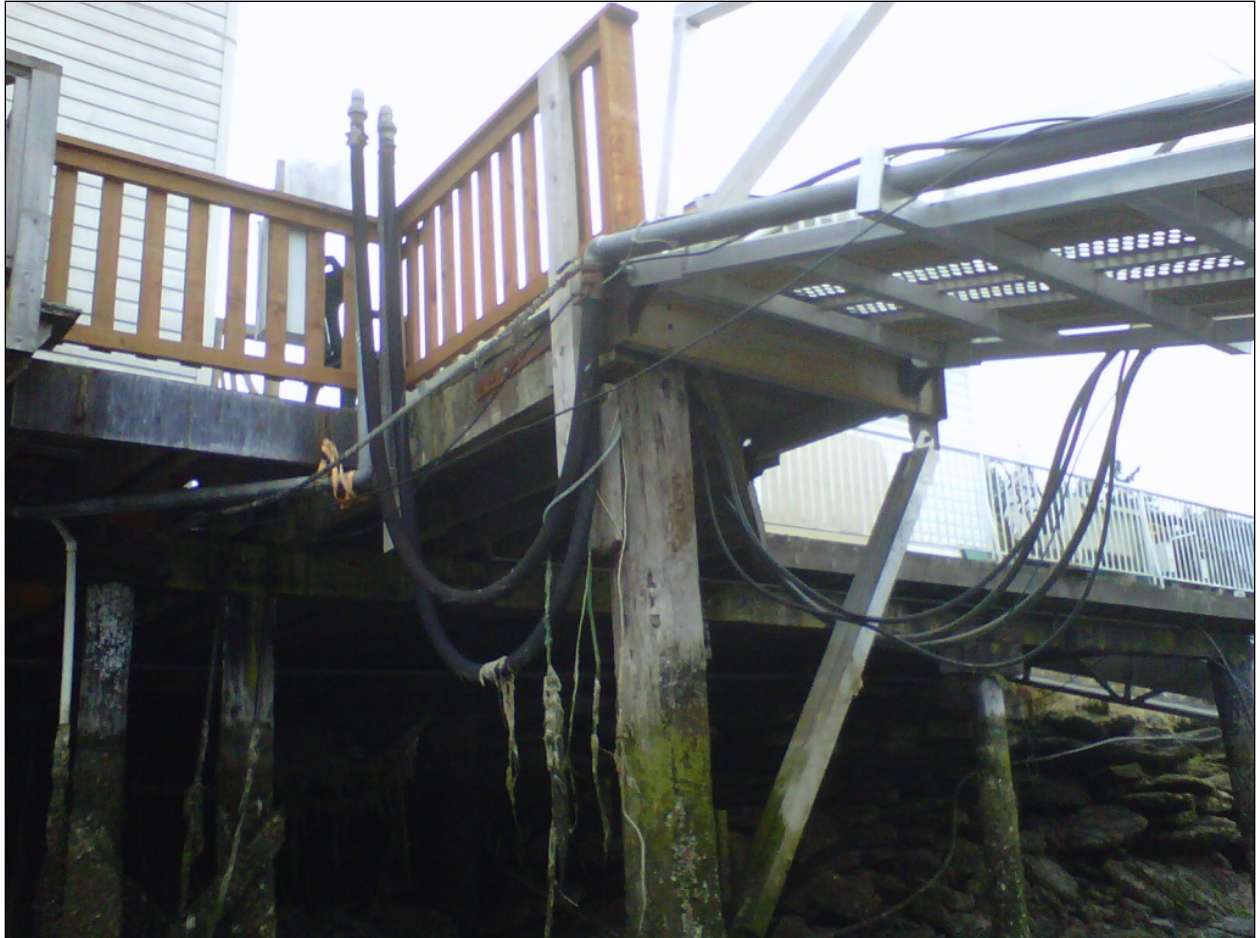
- Pier 66 provides moorage to six float homes. The only services recognized were water, power, and fuel servicing the gas bar.
