FINAL REPORT

Cowichan Bay Float Homes and Live-aboards

Prepared for:
Cowichan Valley Regional District
Community and Regional Planning Division

File: 1123-002.01
February 2013

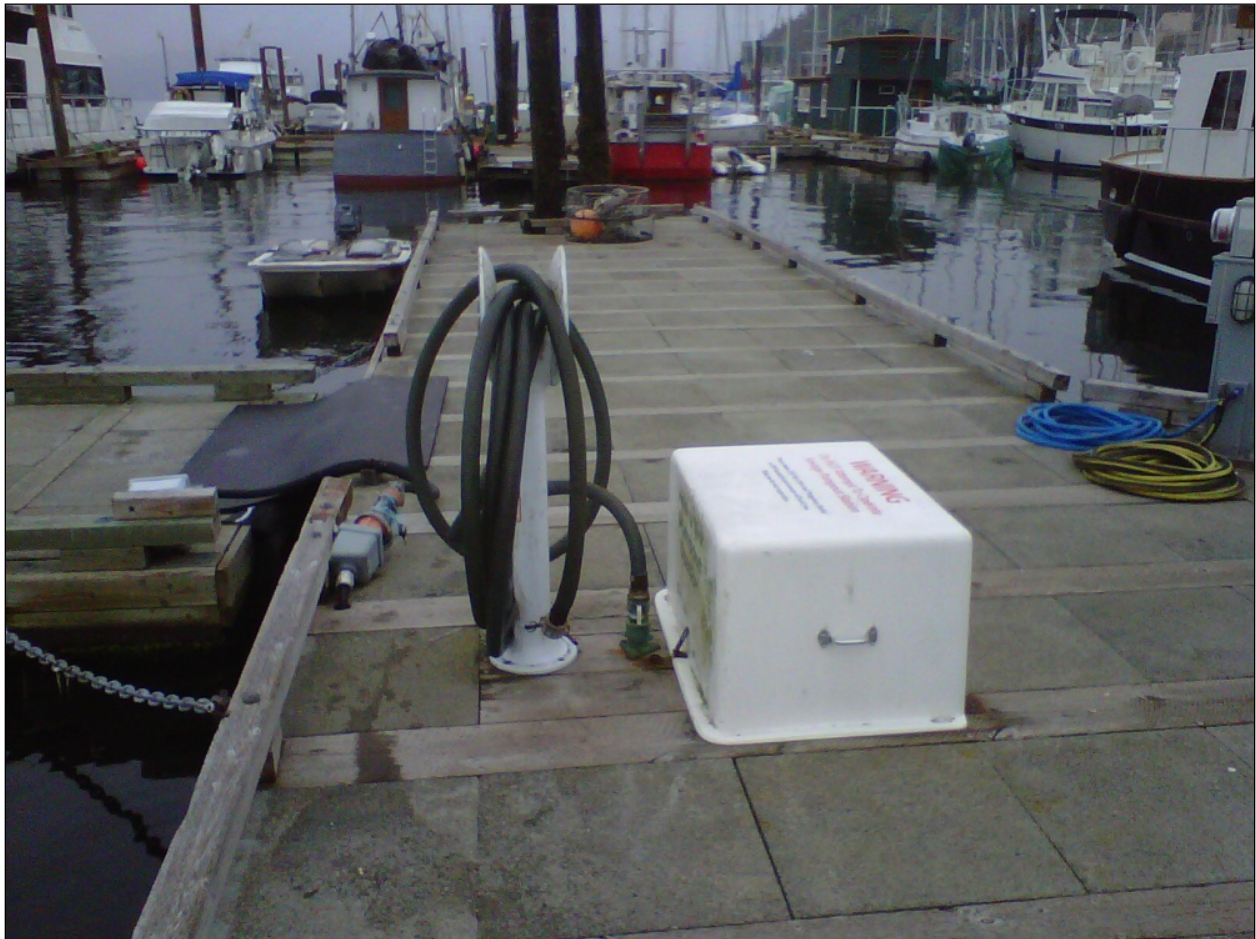
- The Dungeness Marina is equipped with a boat sanitation dump located at the far end of the main wharf. The cover is secured, but it would be assumed that there would be a pump and small holding tank beneath the cover.

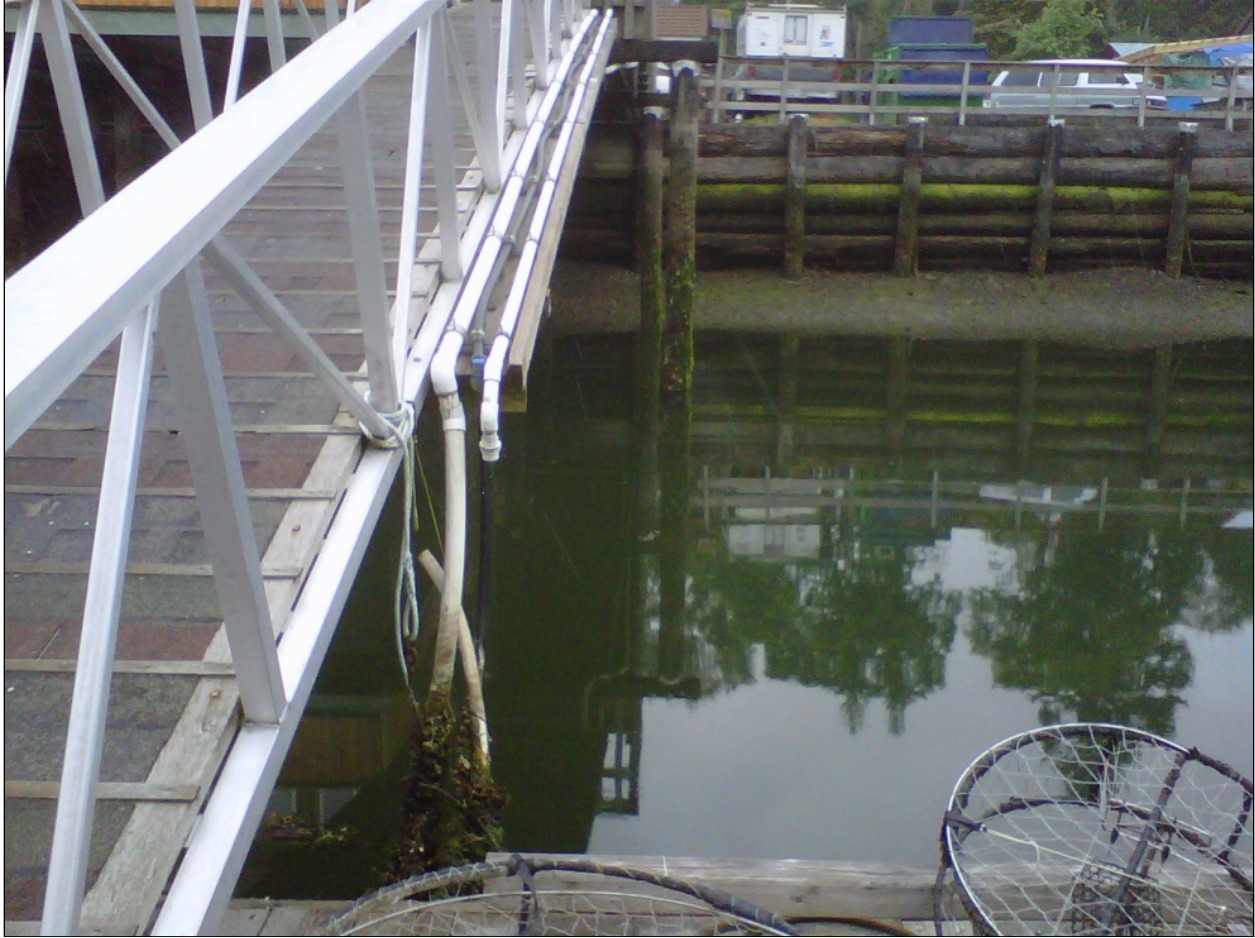
- The Force Main from the boat sanitation dump, although not entirely visible seems to be constructed from 50mm Spa Flex pipe along the wharf and ramp at which point it transitions to Schedule 40 PVC through a compression fitting.

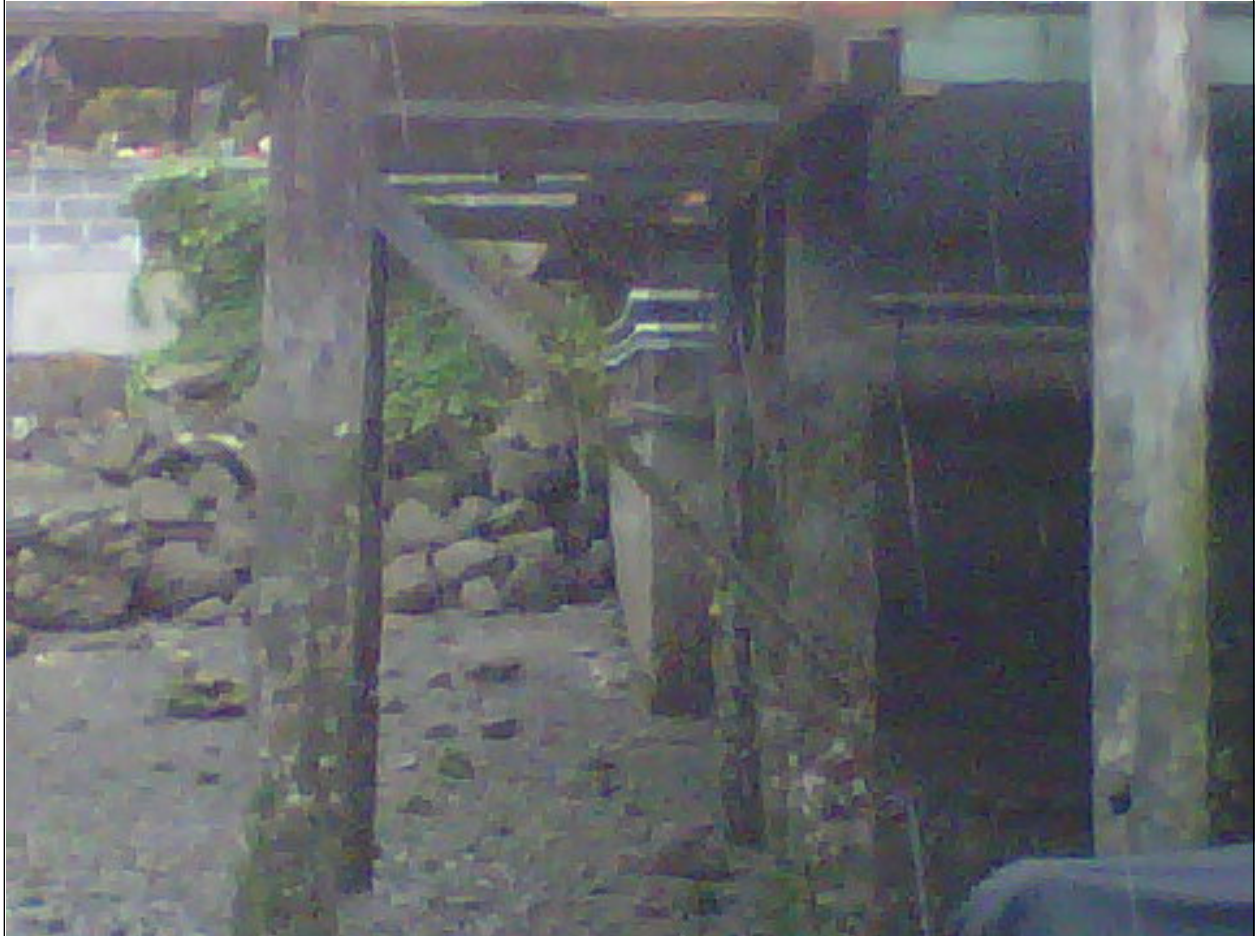
- The Force Main Continues under the dock where it is believed to tie into the gravity sewer servicing a number of buildings including a restaurant before entering the CVRD sanitary sewer.

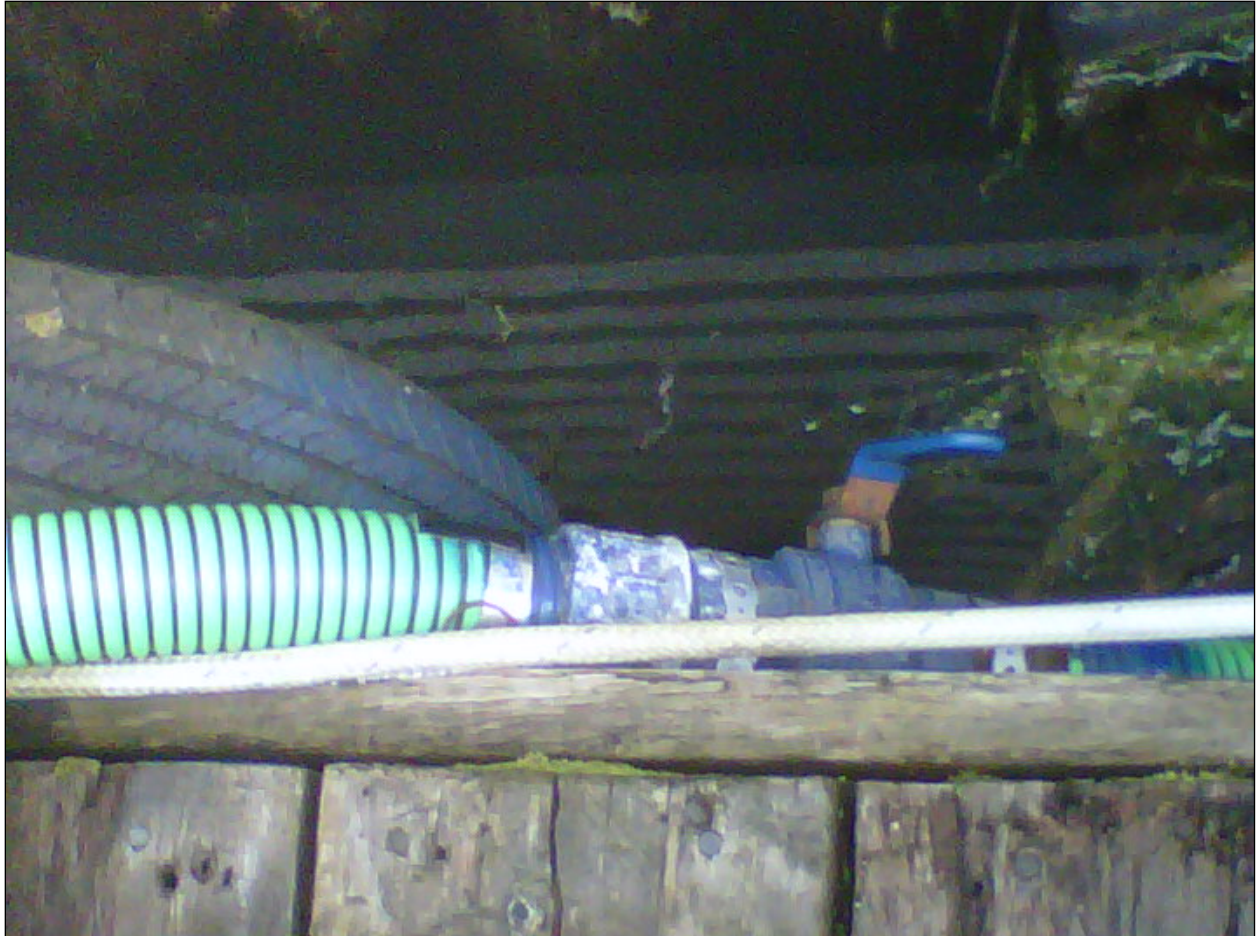
- The Bluenose marina has provided moorage for 5 float homes. There is a sewer management system in place servicing three of the float homes along with a washroom facility located on the wharf. The system seems to be generally constructed from 50mm black EPDM hose which has a working pressure of approx 60psi.

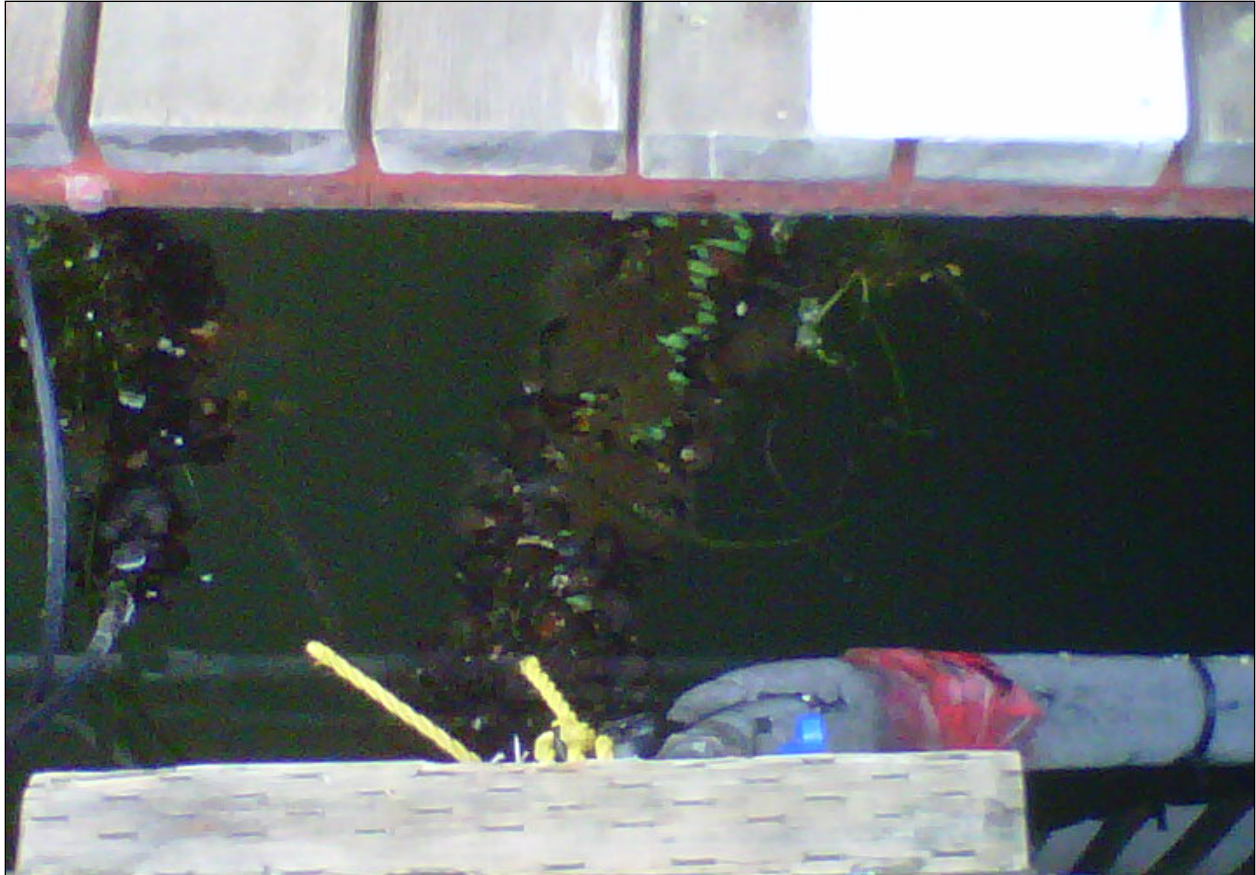
- The hose is routed through the wharf system occasionally submerged into the water

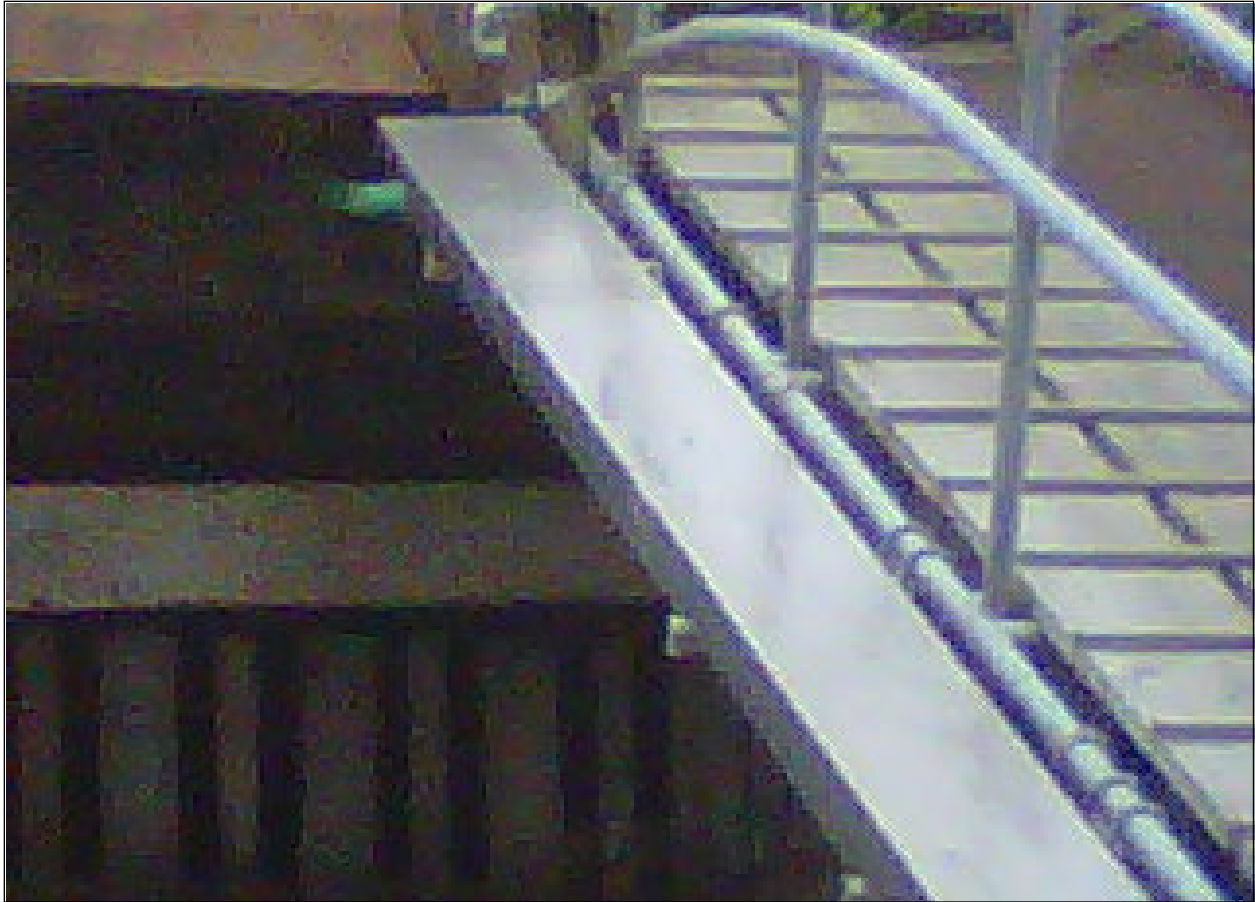
- The force main continues from the wharf up the ramp to the dock system.

- The force main was traced back to building occupied by a business, the merchant mentioned that the force main outfall went into a holding tank inside the building. Access to the tank could not be provided; it can only be assumed that the tank discharges to CVRD sewage collection system.
