Cowichan Lake Erosion Assessment

Draft Report
February 2011

KWL File No. 673.017

**KERR WOOD LEIDAL**
associates limited
CONSULTING ENGINEERS

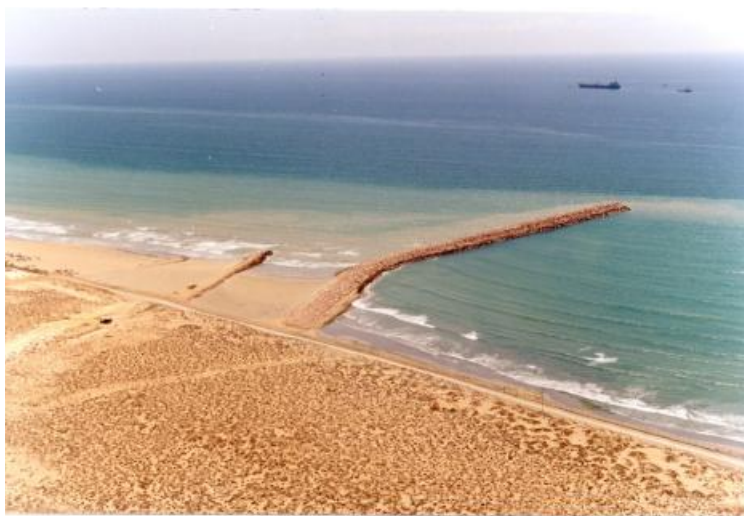
Figure 2-1: Longshore Sediment Transport around a Groyne (Drift Direction from L to R)

Beaches can be subject to waves of differing heights and directions throughout the year; as a result, the direction of longshore drift can change throughout the year. However, when the wave “climate” in a location is considered (wave heights, periods, directions and durations) there is usually a **net** longshore drift direction. A photo of longshore sediment drift around a groyne (structure constructed perpendicular to the shore) in Yemen can be seen in Figure 2-1.

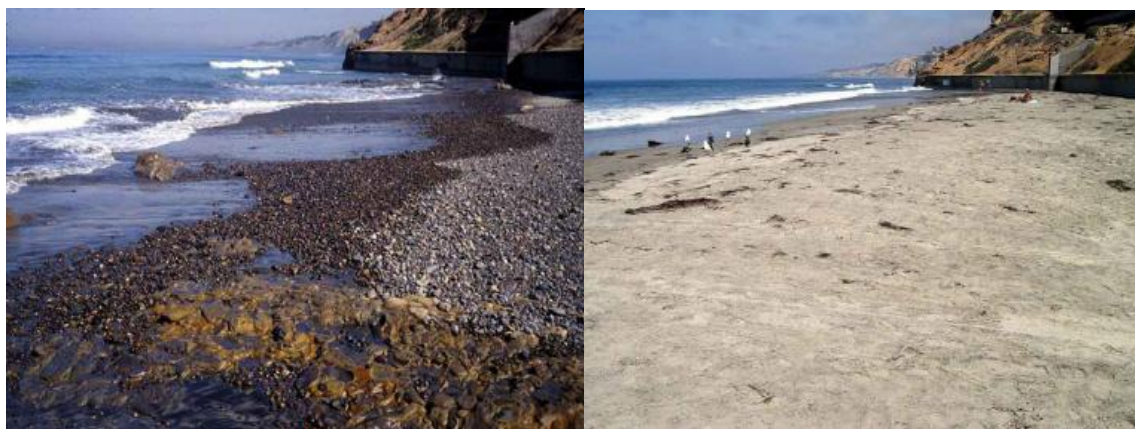
Figure 2-2: Winter (Left) and Summer Beach Profiles, La Jolla, California

conditions often have “summer” and “winter” profiles. During the winter, large storm events and higher, steeper waves cause sediment to be transported offshore and deposited in submerged “bars”. During the summer, lower, less steep waves cause the sediment to be carried up the beach and redeposited. Photos of a beach in La Jolla, California (taken in winter and summer), which illustrate this process can be found in Figure 2-2.

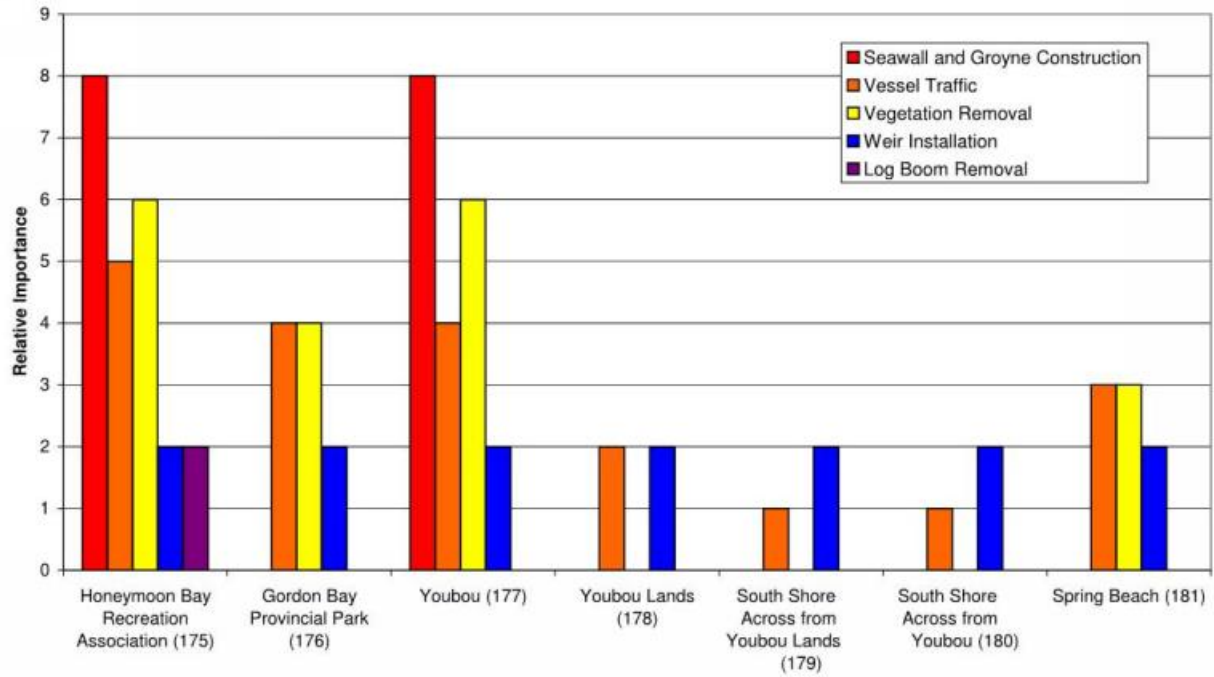
Figure 5-2: Relative Importance of Erosion Mechanisms at Each Site

As outlined above, there are numerous potential causes of the erosion observed at Cowichan Lake. The relative importance of each erosion mechanism has been ranked for each site and is shown in Figure 5-2.

The “importance level” is quantified on a scale of 1 to 10. It should be noted that the importance level for each mechanism is not based on data, but solely on the site observations, discussions with local residents and professional judgement. The sum of the importance factors is higher at sites where there are more signs of progressive erosion.

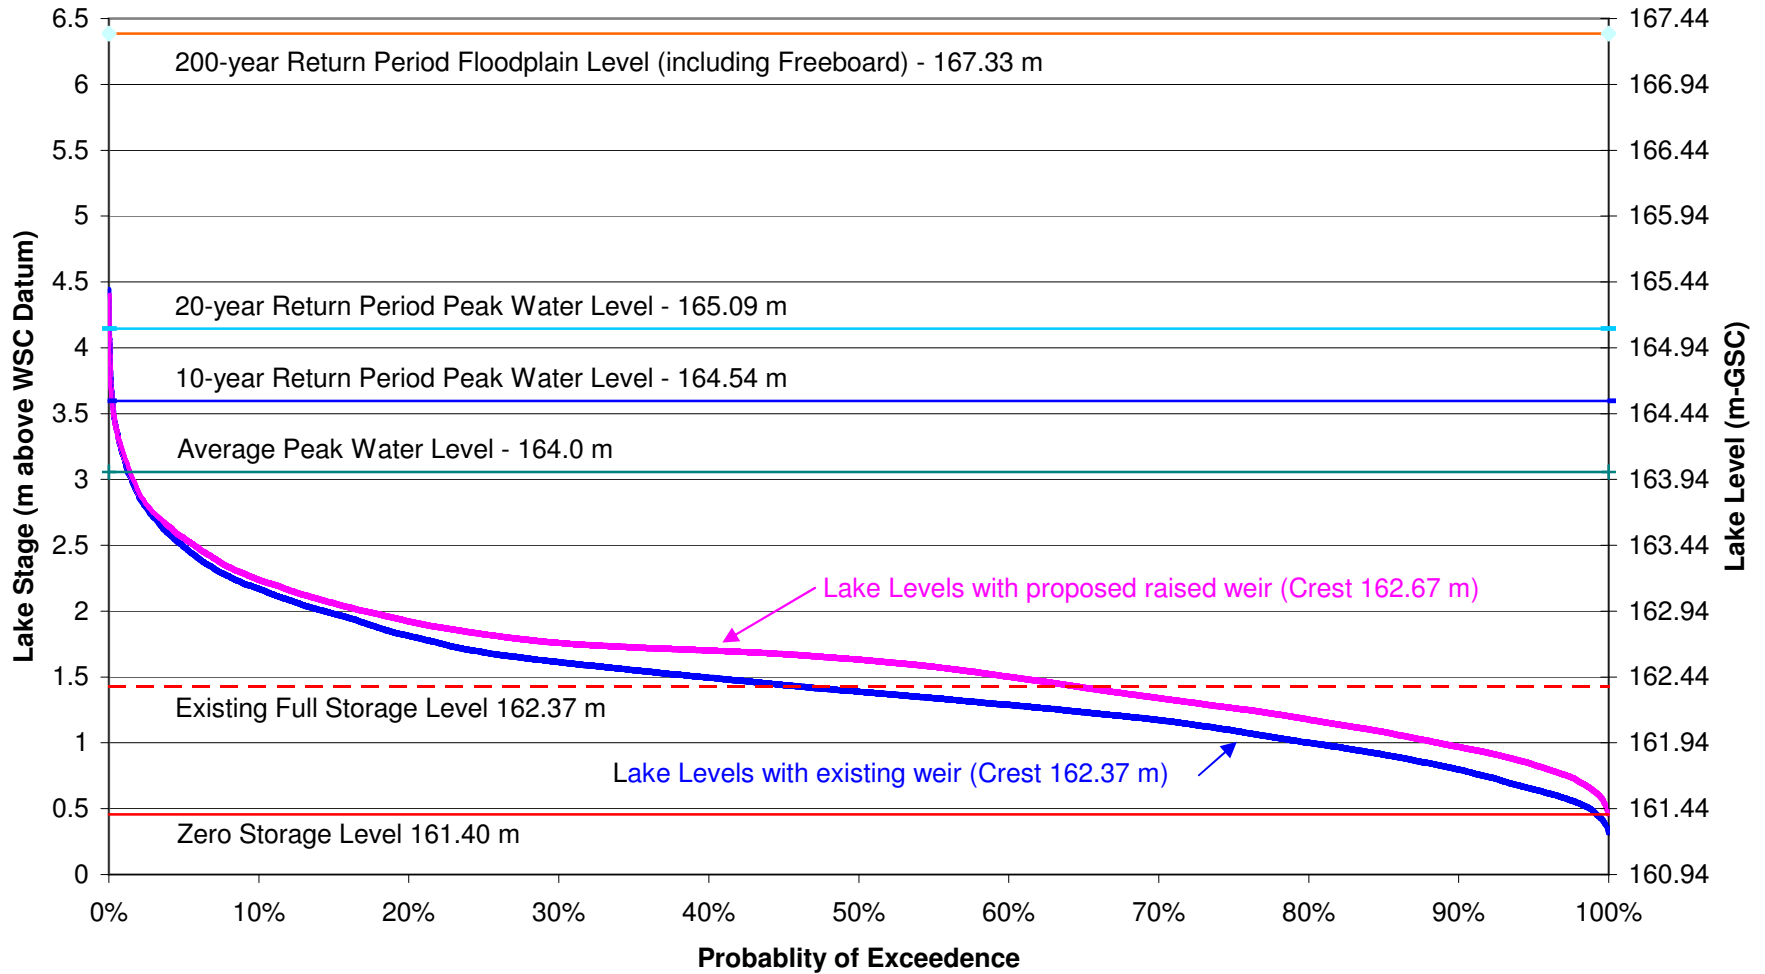
Kerr Wood Leidal Associates
Cowichan Lake Erosion Assessment (Project 0673-017)
Cowichan Lake Levels: 1962 to 2007

Water level exceedance probabilities for existing and raised weir conditions are provided graphically in Appendix B. Also provided in Appendix B are graphs of average, maximum and mean water levels over a year for existing and raised weir conditions.

Water level exceedance probabilities for existing and raised weir conditions are provided in Appendix B. Generally, extreme high water levels (that occur less than about 4% of the time) are unchanged. For lower water levels, the level at a given exceedance probability is increased by about 0.25 m on average; for example, the median (50%) water level is currently 162.33 m GD but will rise to 162.58 m GD if the weir is raised. Key water levels with and without raised weir conditions are summarized in Table 6-1.

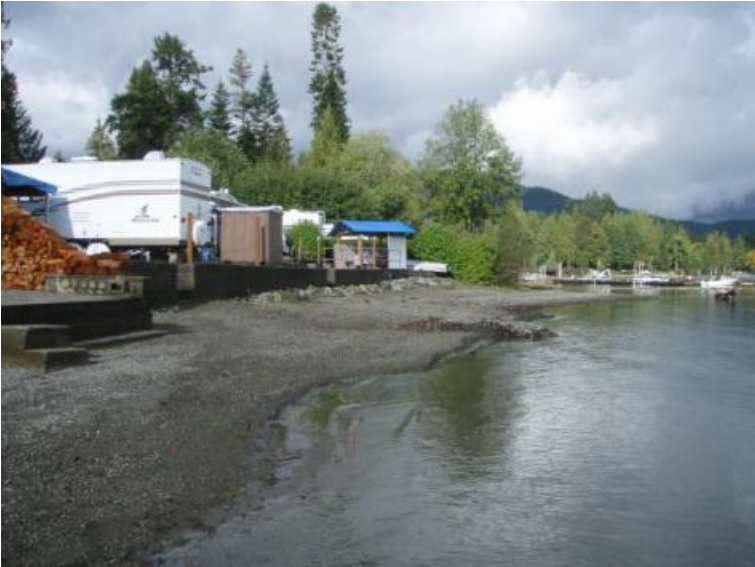
Way-point	Field Observations
175	<p data-bbox="407 384 1287 415">Honeymoon Bay Recreation Association, west of Sutton Creek mouth</p> <ul data-bbox="407 415 1409 611" style="list-style-type: none">▪ beach slope = 15°▪ substrate = sand and fine gravel;▪ fronted by concrete seawall ±0.6 m high located ±0.3 m above water level (varies);▪ property protected by single log floating breakwater;▪ riprap (D50 = 75 mm) protecting toe of wall where underside of footing is exposed;▪ small coarse gravel groyne installed towards east end of wall. <p data-bbox="407 646 1157 678">Beach Fronting Honeymoon Bay Rec. Association Property</p>

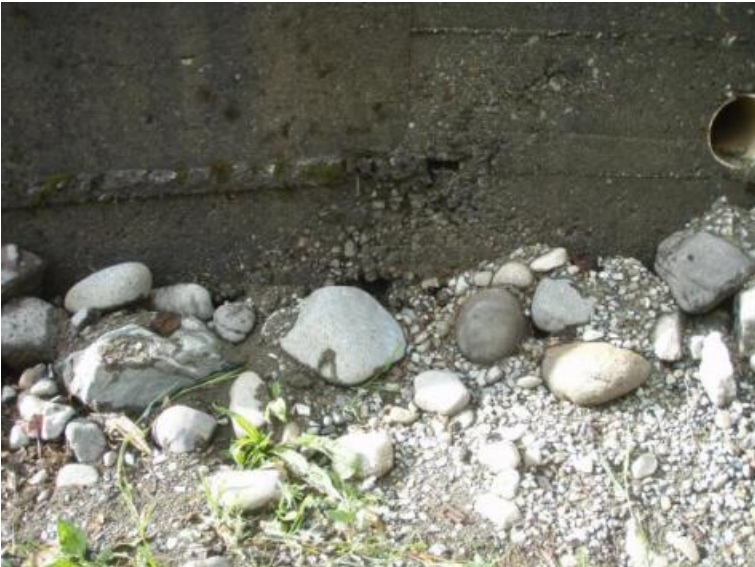
- Eroded seawall toes resulting in exposed footings in some cases. Eroded seawall toes were found at elevations ranging from about 162 m GD to 164 m GD at Waypoints 175 (Honeymoon Bay Recreation Association) and 177 (Youbou).

<p data-bbox="407 1276 1114 1308">Erosion at Toe of Retaining Wall with Rip-rap Protection</p>

At the Youbou site, exposed wall foundations were found on one property but not at an adjacent property; this would suggest that construction practice likely plays a role in the occurrence and severity of seawall toe erosion. Good seawall construction practice is to locate the footing sufficiently deep to prevent undermining when seasonal scouring occurs, or provide riprap protection for the toe to prevent scour if a shallow footing is constructed.

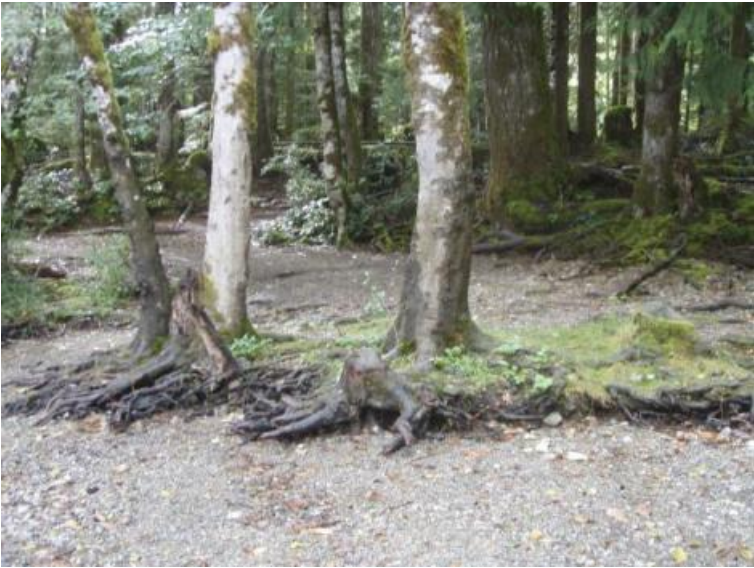
- Exposed tree roots at elevations around 162.4 m GD were found at all sites except Waypoint 175 (Honeymoon Bay Recreation Association site), which appears to have had all trees removed. In all cases, there was no evidence of new trees establishing themselves at this elevation (except “shooters” from larger trees/bushes). Investigation of the trees in question by Meridian Forest Services on October 7, 2010 (see report in Appendix D) indicates that trees that exhibit root erosion are typically alders and cottonwoods. The trees investigated by Meridian range in age from 36 to 53 years. There are very few, if any, conifers established at this elevation.

Way-point	Field Observations
176	<p>Gordon Bay, just east of swim area breakwater;</p> <ul style="list-style-type: none"> ▪ 15° beach slope; ▪ substrate = gravel/fine gravel/sand; ▪ root exposure to ±2 m above water level; ▪ no dunes indicating significant erosion at a particular water level; ▪ mature alder trees with eroded roots present; ▪ no young alders growing at same elevation as mature trees; <p>Root Exposure at Gordon Bay Provincial Park</p>

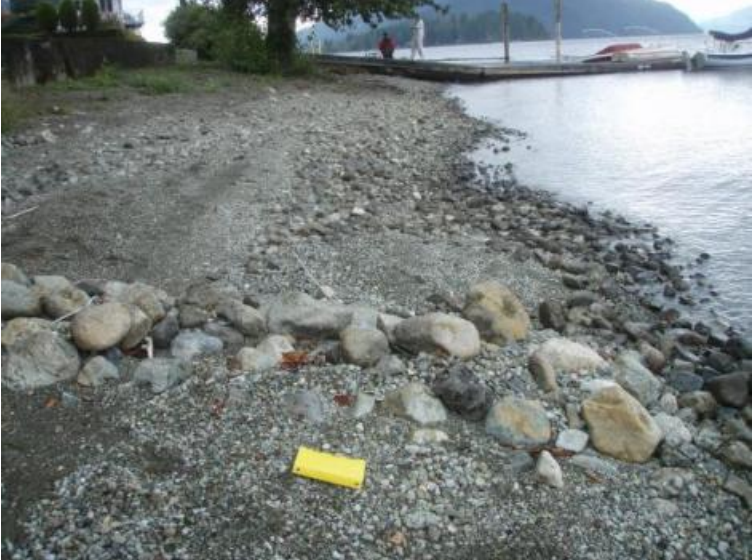
As previously discussed, seawalls and groynes can disrupt the flow of longshore and cross-shore sediment transport resulting in net sediment deficiencies and erosion. The sites at Waypoints 175 (Honeymoon Bay Recreation Association) and 177 (Youbou) have seawalls that exhibit toe erosion and footing exposure. There is evidence of a net west to east longshore sediment transport in the accretion and erosion behaviour at the groynes in the area of the Youbou site.

Way-point	Field Observations
	<p data-bbox="407 388 1382 420">Up-drift Sediment Deposition at a Small Groyne West of the Youbou Property</p>

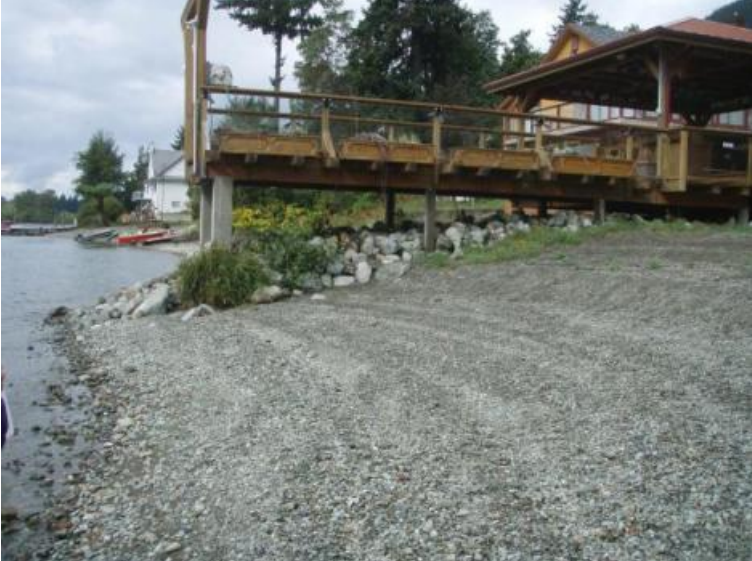
<p data-bbox="407 1018 1421 1081">Leaside (East) Erosion Cut-back at a Larger Groyne West of the Youbou Property</p>

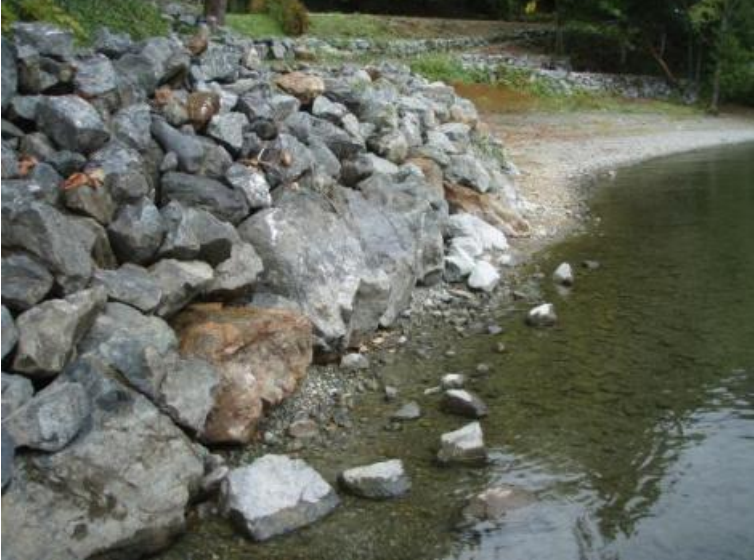
Way-point	Field Observations
	<p data-bbox="407 348 1292 380">Riprap Revetment to Water Level at Property East of Youbou Property</p>

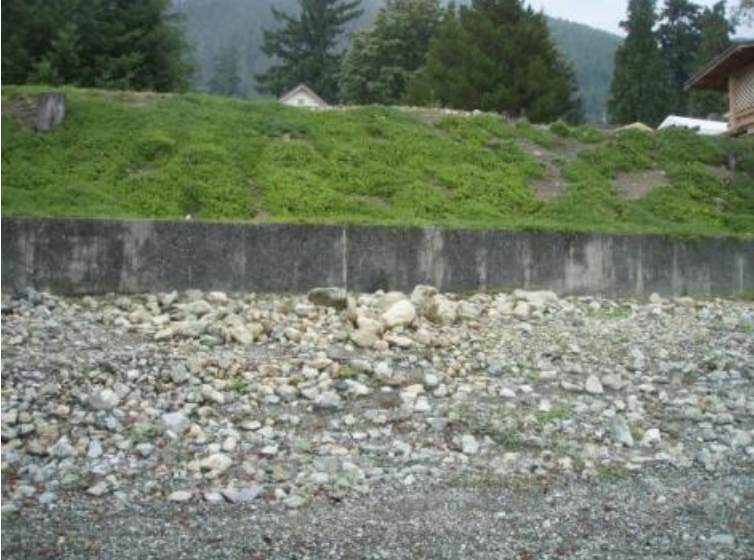
<p data-bbox="407 978 1321 1010">Toe of Concrete Seawall with Deeper Footing (West of Youbou Property)</p>

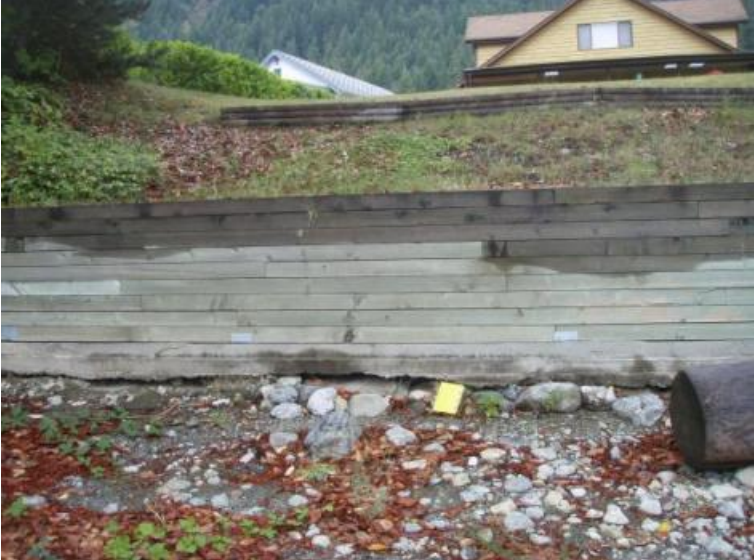
Way-point	Field Observations
	<p>Eroded Toe of Concrete Seawall with Shallow Footing (West of Youbou Property)</p>

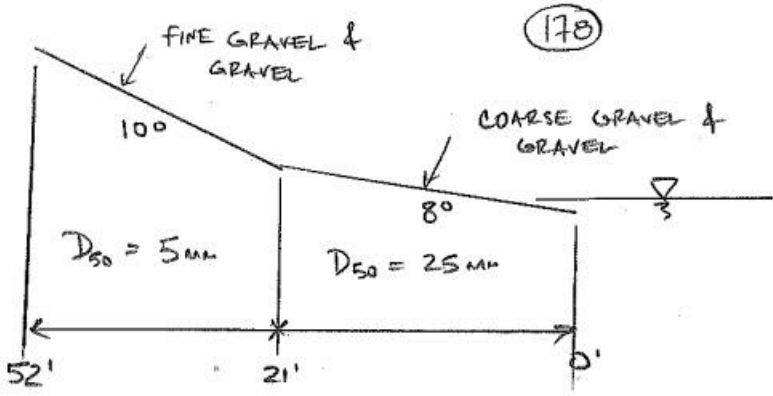
178	<p>Youbou Lands, West Side</p> <ul style="list-style-type: none"> ▪ see sketch for slope and substrate; ▪ westerly exposed gravel beach with no structures; ▪ Alder trees (30 cm diameter trunks), with eroded roots; ▪ Fir trees do not have eroded roots at same location and elevation;

Way-point	Field Observations
	<p data-bbox="407 348 764 380">Beach at Youbou Lands Site</p>   <p data-bbox="407 978 773 1010">Tree Exhibiting Root Erosion</p>

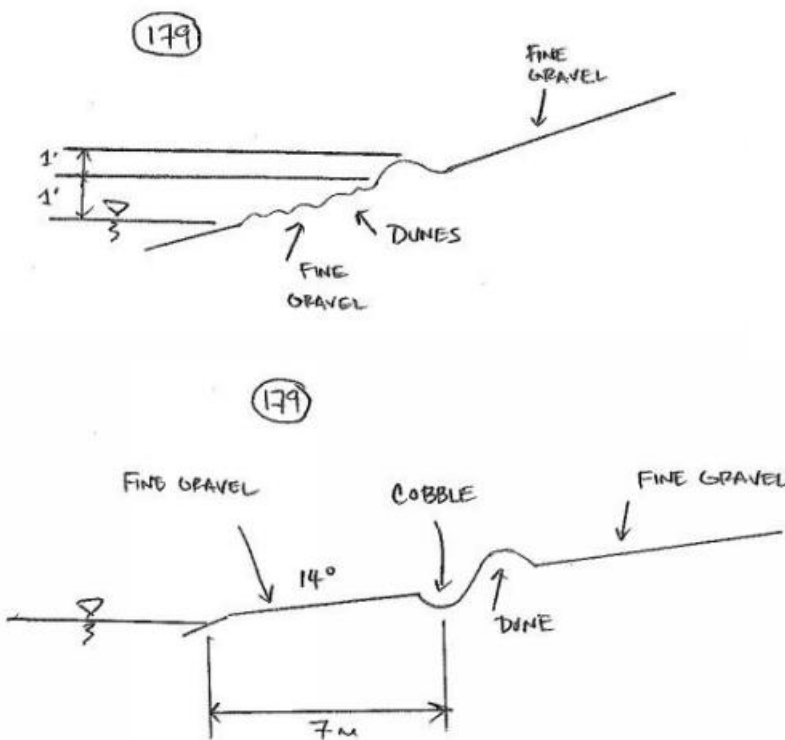
Way-point	Field Observations
179	<p>South shore of lake, across from Youbou Lands;</p> <ul style="list-style-type: none">▪ see sketch for slope▪ substrate = uniform fine gravel with little sand;▪ many small dunes;▪ major dune at +/- 0.3 m above water level;▪ tree root erosion at +/- 0.6 above water level.

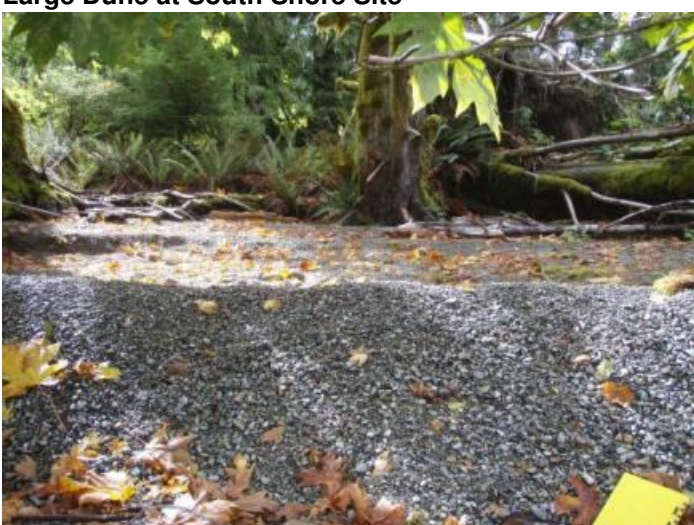
Cross-shore sediment transport is thought to be the dominant cause of the local erosion and dune formation at Waypoint 179 (South Shore Across from Youbou Lands). It is believed that the dune formation is **not a sign of progressive erosion at this site** and the beach likely erodes, rebuilds and reshapes as storm events and milder wind/wave events occur at different water levels.

<p>Large Dune at South Shore Site</p>

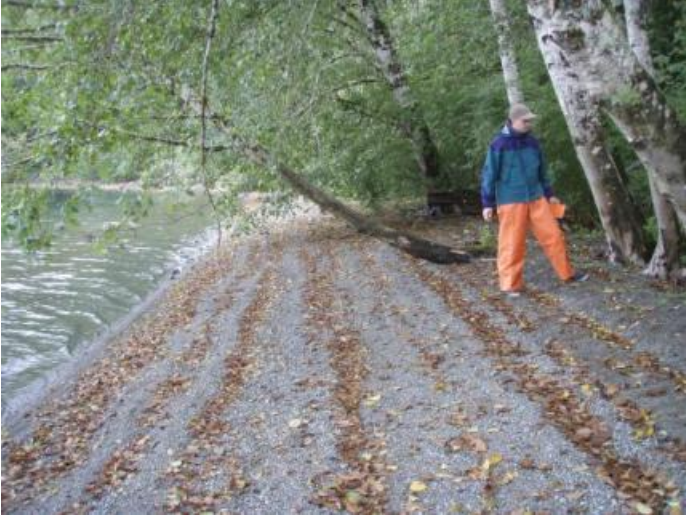
Way-point	Field Observations
180	<p data-bbox="407 348 1416 380">South shore, across from Youbou (gravel beach sheltered from westerly waves)</p> <ul data-bbox="407 384 1354 573" style="list-style-type: none">▪ slope = 10°;▪ substrate = sand and fine gravel;▪ very small dunes;▪ creeping vine to within ±0.6 m of water level;▪ Alder/Cottonwood root erosion present all along beach at ±0.5 m above water level; <p data-bbox="407 611 748 642">Sheltered South Shore Site</p>

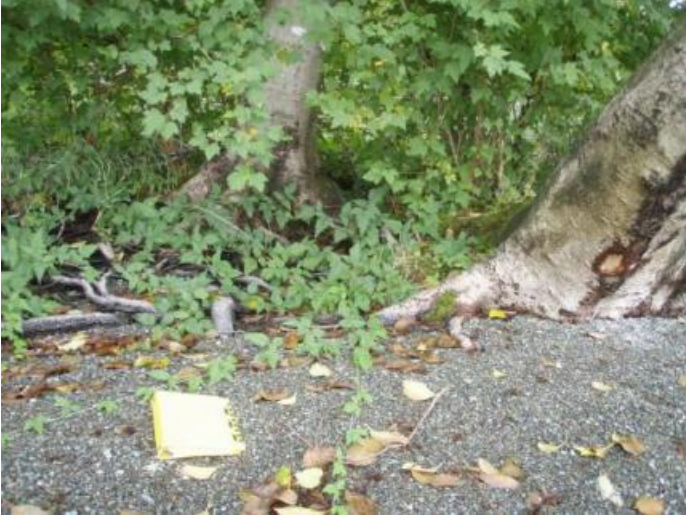
<p data-bbox="407 1192 639 1224">Tree Root Erosion</p>
