Ministry of Environment April 2010

The objective of the Provincial Lakeshore Compliance project is to determine the extent and character of non-compliance along lakeshores in British Columbia (B.C.), and develop solutions to address the problems if and where they exist. The project is focused on lakefront residential developments.

This document is a report on Phase 1of the project which occurred in 2008.

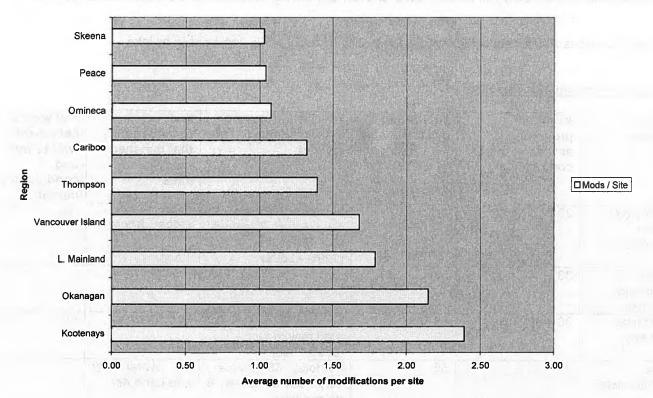
Chart 1 - Average Modification per Site in each Region

There were 872 modifications (docks, retaining walls, groynes, and boat launches) on the compliance sites, averaging 1.5 modifications per site. Chart 1 shows the average modification per site within each region (this chart does not include the work done by regional staff on Skaha Lake in the Okanagan Region). Kootenay Region had the most modifications per site visited; Skeena region had the fewest. The areas with the highest modifications per site again correlate with the areas of the province with the highest urban growth pressures. The majority of the modifications observed were dock structures followed closely by retaining walls.
